PLATFORM SUSTAINMENT – LESSONS LEARNT ON AN AGEING AIRCRAFT

Paul van Staden*

***Boeing Defence Australia Limited**

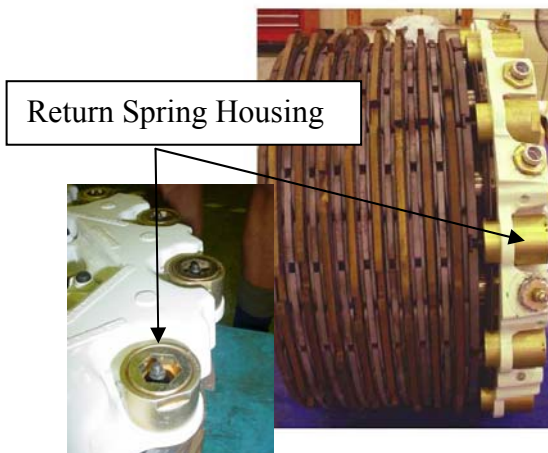
Figure 2.1.1 Main Wheel Brake Assembly

In 2006, two serious brake assembly failures occurred resulting in the associated main wheel deflating during the landing process. In 2007, six related failures occurred within eight months. This dictated an in-depth investigation into all brake system components from the cockpit through to the rubber compound of the

As a result it was found that prior to 2006 a modification to the main wheel brake assembly was carried out to alleviate similar occurrences, but to no avail. Investigations were coming to a head to the extent that the operational crew was being questioned as to what brake pedal effort was being applied.

While conversing with the maintenance crew regarding the operation of twelve return spring assemblies (See Figure 2.1.1) on the brake unit, it was found that the maintenance crew were not fully conversant with the operation of a grip and tube assembly in the twelve return spring housings.

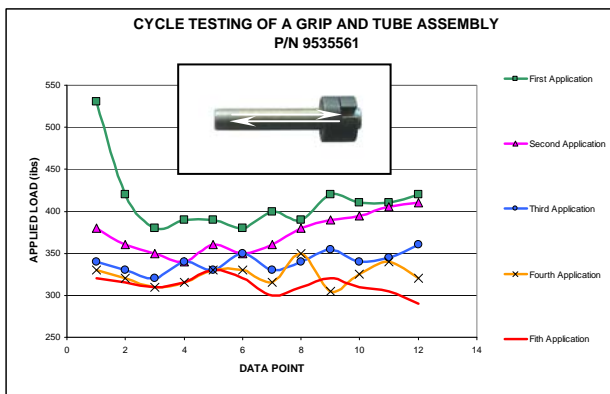
Figure 2.1.3 Grip and Tube Recycling Test

Degradation of this interference fit resulted in residual hydraulic pressure of 100 psi applying mild braking force on the wheels during taxiing. This braking force was not felt during take-off but would generate enough heat to bind the

Because the grip and tube assembly is downstream of the anti skid circuit, the anti skid system could not control the resultant wheel lockup and thus deflation on landing. Although maintenance publications dictate replacement of grip and tubes when the grip has travelled down the full length of the tube, maintenance personnel have become complacent through re-positioning the grip on the tube for re-use. Figure 2.1.3 illustrates why this practice would have gone unnoticed for many years until degradation of the interference fit, through re-use of the grip and tubes, would result in failure of a brake assembly.

The 100 psi residual pressure would overcome the grip and tube interference fit when the applied force to move the grip fell below 300 lbs. (After the fifth application of the same grip and tube as illustrated in Figure 2.1.3.) A compounding factor is that the **form** and **fit** of a “used” grip and tube is identical to that of a “new” grip and tube. In addition, the **functionality** of a “used” item is not far removed from that of a “new” item where a new item can only be verified through certified testing.

Appropriate training could have avoided the increase in failure rate. Training programs generally provide operational, removal, installation, inspection and system testing of various platform components, assemblies and

sub-assemblies. Primary components, with respect to technical airworthiness and system safety should enjoy a more in-depth training regime that should include a fault tree analysis and failure mode identification as a test to confirm the maintainer has the required depth of knowledge to ensure airworthiness of the platform.

One can explain the working principles of the associated grip and tube in the brake assembly to the student, (the concept of interference fits is as well known as locking wire or a split pin) but nothing has triggered the student to think about the consequences of all its failure modes. This two-way approach should be mandatory for primary components.

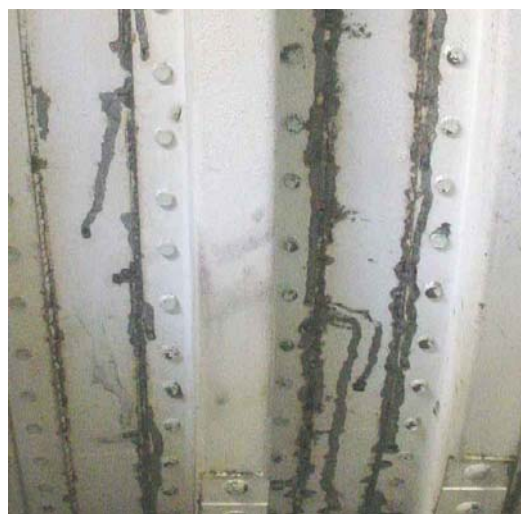
Figure 3.1.1 Example of PR 1750 sealant reversion

Sealants of various types and manufacture are used extensively within the aerospace industry to form a gas/liquid tight seal between two surfaces. Leak testing is carried out at prescribed intervals to ensure/repair the integrity of the sealant interface. However, through ageing, one encounters sealant reversion, a term used when the cured sealant “reverts” to its uncured or original state.

In extreme cases, reverted sealant can flow from joints under the influence of pressure and

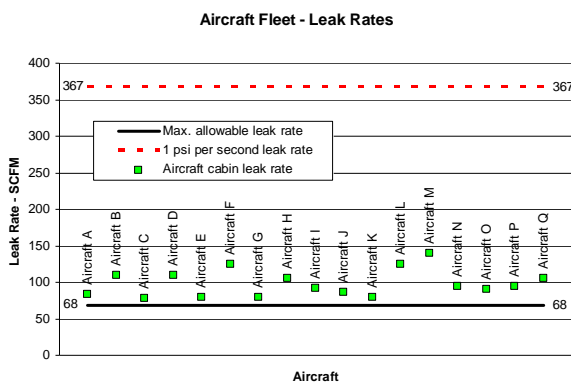
Figure 3.1.2 Snap Shot (2005) of Fleet Leak Rates

gravity such as in the crew module of an ageing platform. Figure 3.1.2 depicts crew module pressurization leak rates registered in 2005 against a fleet of aircraft with all aircraft having excessive leak rates above the maximum allowable as a result of sealant reversion.

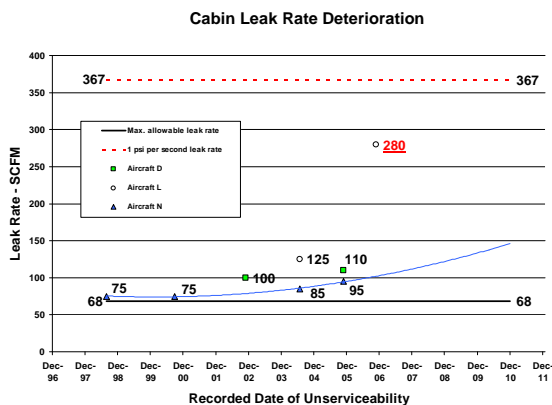
Figure 3.1.3 Leak Rate Deterioration

The leak rates given against the CFU's indicate increasing values over time. The CFU typically being terminated through the statement:

Typically, a high altitude military aircraft has a cabin pressurisation leak rate range between 38 standard cubic feet per minute (scfm) production leak rate and a maximum 68 scfm in-service leak rate. Figure 3.1.3 illustrates a range from 75 scfm to as high as 280 scfm. The 'worst case' condition.

The CFU therefore has never been rectified and the reasons have been carried over to later CFU's without considering the impact of the increasing cabin pressurisation leak rates. The consequences of having excessive cabin leak rates on airworthiness are:

One of the causes for the increasing trend in leak rates is the inability to determine the location of possible leaks. Because of the structure of the crew module, certain areas have not enjoyed sufficient re-sealing as a result of the difficulty in identifying areas of leakage

The infrared exercise was carried out on Aircraft L as depicted in Figure 3.1.3 and after repair and testing the leak rate was reduced from 280 scfm to below the maximum allowable and measured at 67 scfm. This process is now formulated into the appropriate maintenance publication as approved practice for leak detection of the crew module.

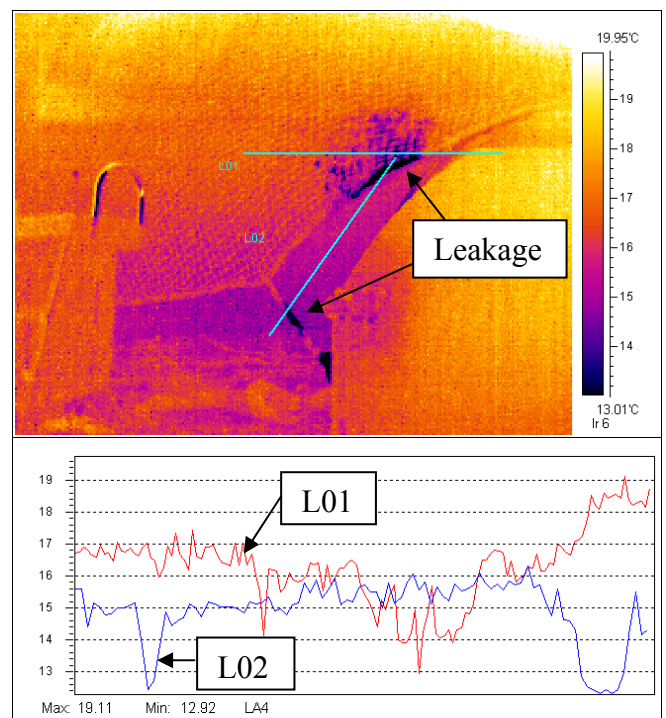
Figure 3.2.1 Infrared image of crew module leakage with temperature plots.

Figure 3.2.1 shows leakage at the windshield and crew module panels with a temperature drop of approximately 2 degrees Celsius (See L02 of Figure 3.2.1). Figure 3.2.2 illustrates the capability of infrared to determine leakage at fasteners interfaced with sealant.
