STRUCTURAL TESTING OF C-5A AFT FUSELAGE SKIN PANELS

Abstract

This paper provides a description of how the structural integrity testing of C-5A aft fuselage crown skin panels was conducted.

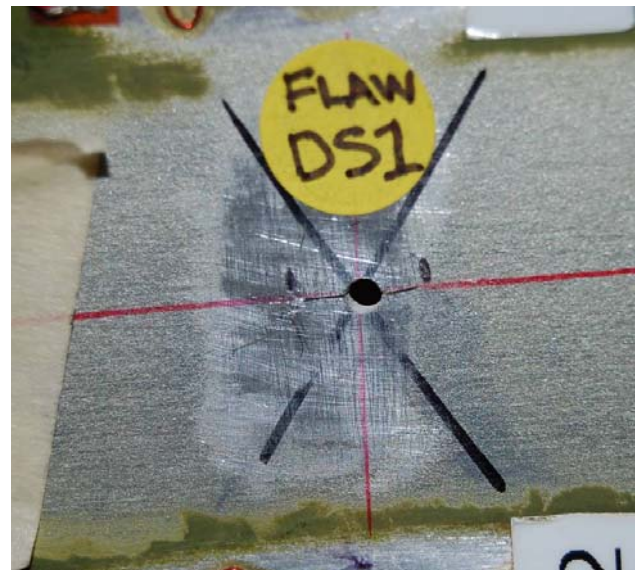
Fig. 11. ST-013 flaw initial installation

The flaw induced in the ST-013 article was a 0.350 inch circumferential cut centered between stringers 91 and 93 at FS 1729. This was accomplished by drilling a #40 hole at desired location and then cutting 90° to the stringers an equal distance to achieve the proper overall centered length. Figure 11 shows the initial installation of the flaw.

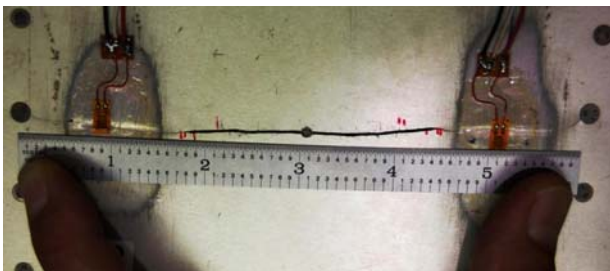
Fig. 13. ST-015 flaw after limit load test #5

Residual strength test #5 was then conducted. During loading at 73% and again at 86% of limit load, small pops were heard from the test article. At 97% of limit a louder pop was heard. The load continued to the limit load value and the panel continued to hold load. The post test inspection revealed that the flaw had extended to the fasteners at stringers 91 and 93. The video of the test showed that the crack had grown at each of the small pops and then run to the stringers at the louder pop where the crack was arrested and the panel was still capable of holding increased load. During the post test inspection the overall flaw was measured as 5.884 inches. A photo of the flaw after residual test #5 is shown in Figure 13.

NIAR consulted with the other TAG team members on how to proceed with testing. It was decided to mechanically extend the flaw 1.000 inch past the fasteners at stringers 91 and 93 in the skin only and then cyclic load to start natural cracks and repeat the residual strength test when the overall length reached 8.200 inches.

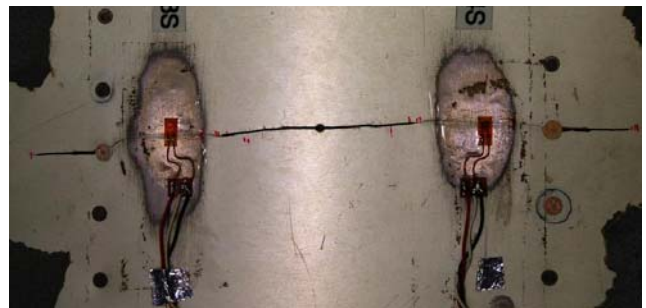
Fig. 14. ST-015 flaw prior to limit load test #6

The flaw was extended and measured 8.097 inches before starting cyclic loading. Cyclic testing was started with inspection every 100 cycles until crack growth was noted and then shortened to every 50 cycles. At 550 cycles the crack had grown to 8.201 inches and the setup was converted to the residual strength test. The panel flaw at this point is shown in Figure 14.

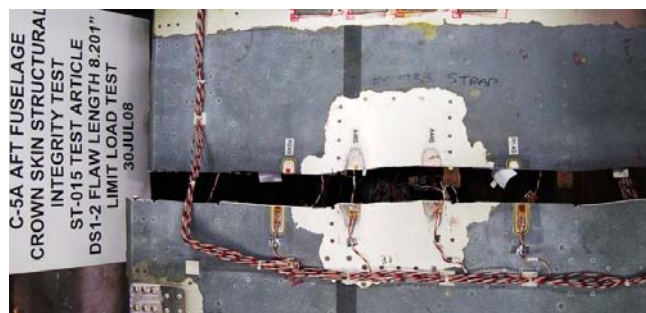
Fig. 15. ST-015 flaw separation after limit load test #6

During application of the residual strength test loads, small pops were heard at 26%, 68% and 74% of limit load. At 78.4% (83,464 pounds) the panel separated along the flaw area as shown in Figure 15.

The panel was removed from the test fixture and small sections forward and aft of the failure region were cut from the panel and sent to CASTLE for fractographic analysis. All areas along the failure point including the stringers, other than the flaw area as previously described, showed only overload failures. This validated the method of mechanically extending cracks

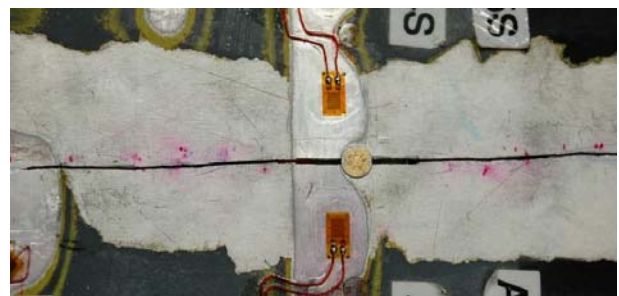
Fig. 16. ST-014 flaw prior to limit load test #5

The flaw was then mechanically extended to an overall length of 5.080 inches and the next residual strength test set for 5.180 inches. Cyclic testing continued until a total of 8,770 cycles were completed at which point the flaw length had reached 5.206 inches as shown in Figure 16.

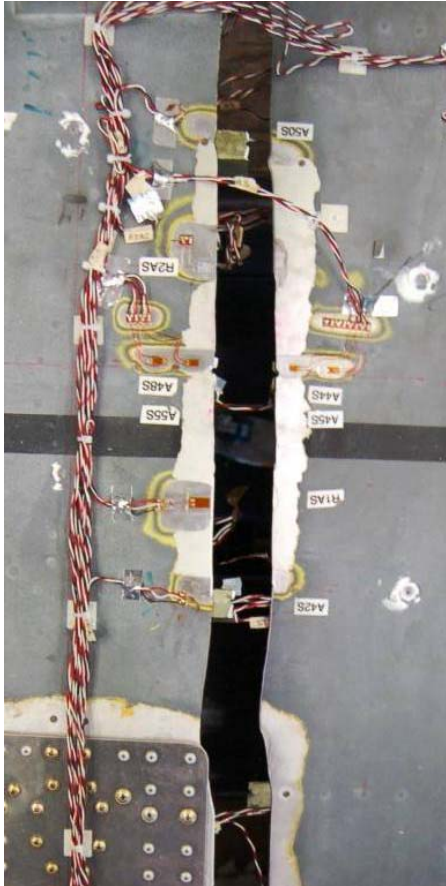
Fig. 17. ST-014 flange separation after limit load test #5

Residual strength test #5 was then conducted on test article ST-014. Testing proceeded normally and small pops were heard

at 81.8% and at 82.5%. Then at 88.6% (94,378 pounds), the test article separated circumferentially along the flaw as shown in Figure 17.

Similar to ST-015, small sections forward and aft of the failure region were cut from the panel and sent to CASTLE for fractographic analysis. All areas along the failure point including the stringers, other than the flaw area as previously described, only showed overload failure.

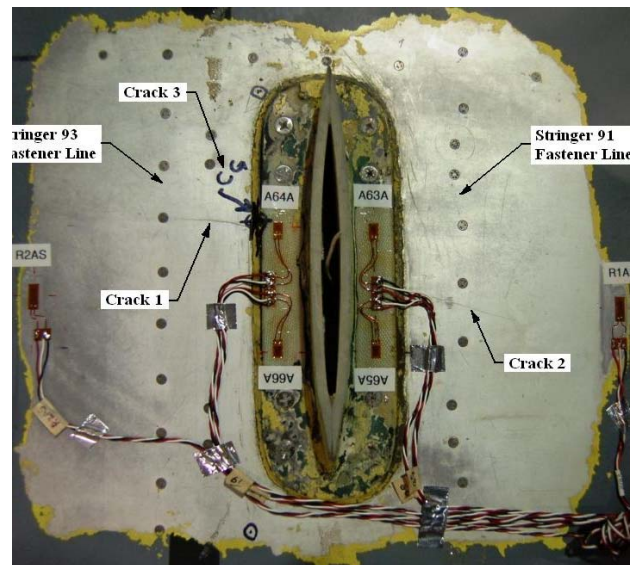
Fig. 18. ST-016 flange (cracks 1, 2, and 3) prior to limit load test #1

The test plan for ST-016 was to conduct a residual strength test only on naturally existing cracks located near the antenna cutout at FS 1704 and between stringers 91 and 93. There were three natural cracks as shown in Figure 18. Crack 1 is an off-axis crack 2.230 inches long. Crack 2 is an off-axis crack 2.570 inches long. Crack 3 is an off-axis crack 0.650 inches long.

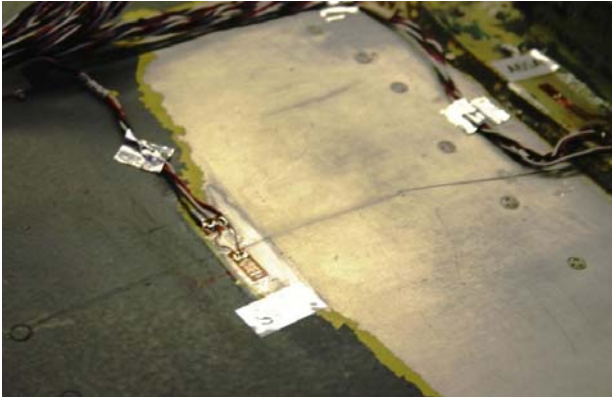
Fig. 19. ST-016 flaw crack 2 after limit load test #1

The residual strength test was then conducted using the same procedures as for previous test articles. The test progressed normally to 87.7% of limit load when a loud pop was heard coming from the test article followed by a louder pop at 89% limit load. The test article maintained load and successfully reached limit load. Post test inspection revealed that crack 2 had grown to a fastener common to the skin and stringer 89 where the crack had been arrested as shown in Figure 19. Crack 2 had grown from the original 2.380 inches to

7.210 inches. Cracks 1 and 3 did not show any crack growth.

After discussion with the TAG team members it was decided to modify the test plan to mechanically extend cracks 1 and 2 past the fastener 0.100 inches, apply cyclic loads until natural cracks initiated, and then repeat the residual strength test.

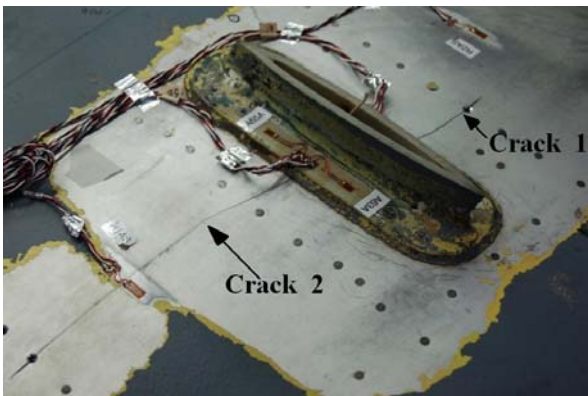
Fig. 20. ST-016 flaw cracks 1 and 2 mechanical extensions at 4,700 cycles

Cyclic testing was then conducted and after 4,700 cycles no crack growth had been detected. It was then decided to extend the cracks an additional 0.500 inches. The crack lengths were now 2.420 inches for crack 1 and 7.950 inches on crack 2. The fasteners that the cracks ran through were also left out to provide more stress at the crack tips, see Figure 20.

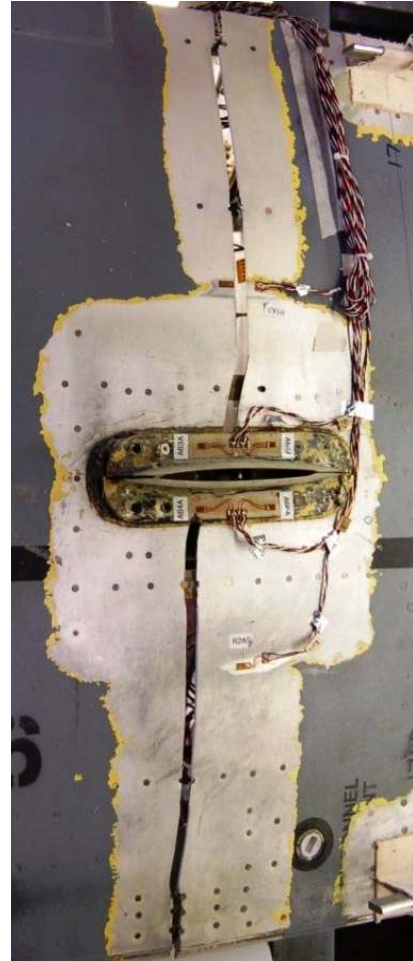
Fig. 21. ST-016 flaw separation after limit load test #2

to residual strength test loads. The loads were applied as with previous residual load tests. The test progressed normally to 60% of limit load when noises were heard from the test article and continued as the load increased. At 69.2% of limit load the article separated circumferentially through the cracks as shown in Figure 21.

As with the previous articles, small sections forward and aft of the failure region were cut from the panel and sent to CASTLE for fractographic analysis. All of the stringer faces, as well as the skin outside the flaw region, showed overload failure only.
