INVESTIGATION OF AN IN-SERVICE CRACK SUBJECTED TO AERODYNAMIC BUFFET AND MANOEUVRE LOADS AND EXPOSED TO A CORROSIVE ENVIRONMENT

S.A. Barter and L. Molent

Air Vehicles Division, Defence Science and Technology Organisation, 506 Lorimer Street,
Fishermans Bend 3207, Australia, Simon.Barter@DSTO.Defence.gov.au;
Lorrie.Molent@DSTO.Defence.gov.au

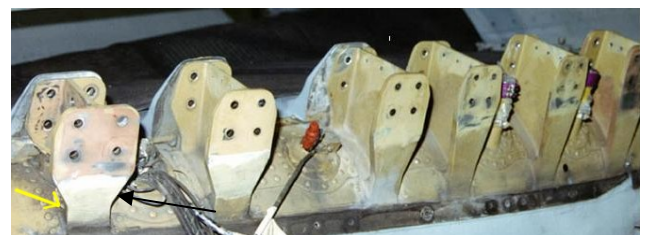
Fig. 1 A view of starboard attachment stubs after removal of vertical tail. The Y598 stub is marked with an arrow (aft is to the left).

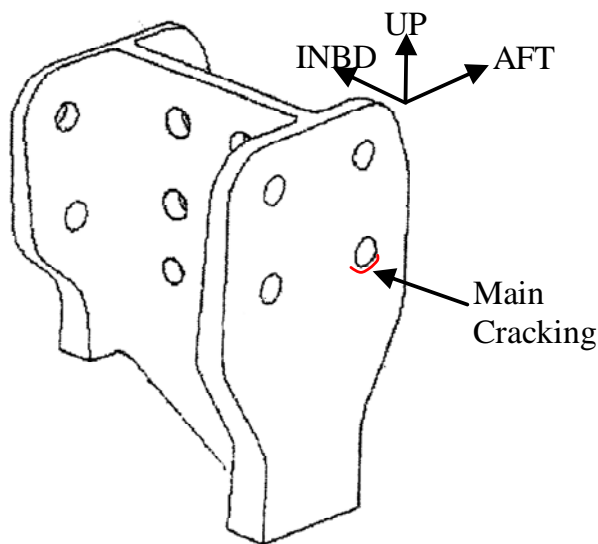
Fatigue cracks have been found by the Royal Australian Air Force (RAAF) in the outboard flange of the attachment stub former using an ultrasonic inspection technique. These cracks are usually adjacent to the aft lower VT attachment fastener holes in one of the aft two stub formers. In one aircraft, at 3088 airframe hours, cracking was found in both aft stubs (the most structurally important) and this led to the stubs being replaced at 3850 airframe hours. As a result, a stub former was sent to DSTO for examination of the cracking. The location of the cracking found by the in-service inspection is shown in *Fig. 2*.

Fig. 2 The position of the detected cracking in the starboard Y598 stub frame, stub attachment.

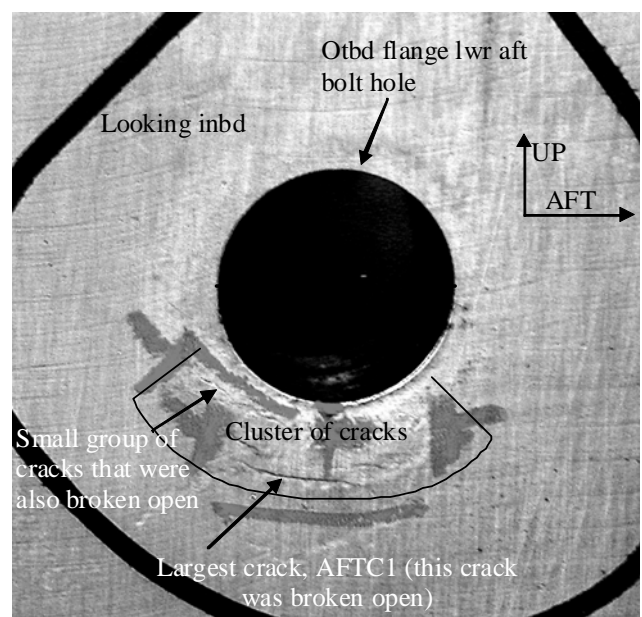
The stub was forged from aluminium alloy 7050-T7452 and was 11.35mm thick at the location of interest. The cracking in the outboard flange near the lower aft fastener hole (diameter of about 10mm) originated from just below the hole in an arc of about 110° starting at about the 4 o'clock position and ending at about the 8 o'clock position (where 12 o'clock is up). *Fig. 3* shows the location of these cracks. The cracks included many small cracks, some of which had joined to form larger cracks. The largest of these was 6.8 mm long on the surface of the flange. Several of the other cracks were about 1-2 mm long on the surface, and some of these overlapped each other and were in the process of joining. No evidence of fretting adjacent to the cracking could be found, and the Ion Vapour Deposited (IVD) corrosion protective coating remained intact over the cracked surface.

Fig. 3 The outboard surface of the stub outboard flange showing the aft lower fastener hole and the cracking about the lower side of this hole. The two sections of cracking that were broken open are marked.

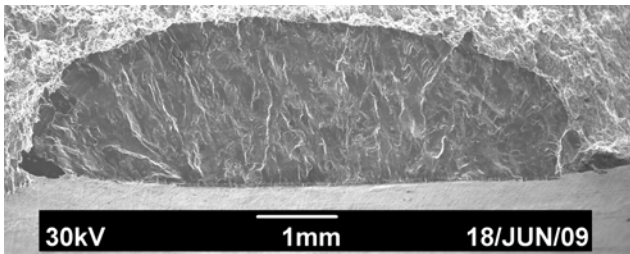
as AFTC2, AFTC3 and AFTC4 (the cluster shown in *Fig. 3*), it was possible to measure their crack depths. At its deepest point from the surface of the flange AFTC1 was about 2.05mm deep. At this section, the flange thickness was measured as 11.35mm. The AFTC1 crack was the product of several cracks that had joined which accounts for its shallow depth in comparison to its surface length, although an examination of the crack's surface did suggest that it was growing faster at the sides than at its deepest region. A view of the surface of AFTC1 is shown in *Fig. 4* (after cleaning the crack's surface).

Fig. 4 View of the surface of AFTC1.

The multiple initiation sources from which this crack and cracks AFTC2, AFTC3 and AFTC4 started were all etch pits beneath the IVD coating. Before breaking the crack open, it was thought that these types of cracks were initiated from fretting damage to the surface, but clearly this is not correct and the discontinuities from which these cracks grew had been present since the former entered service. For this reason, it is most likely that the cracking initiated at the commencement of service (see [2]) and this fact was used in the next section to help develop the crack growth curve.

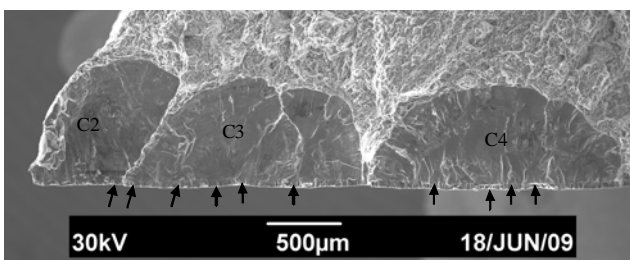
Three other significant cracks AFTC2, AFTC3 and AFTC4 were also broken open and these are shown in *Fig. 5*. Each of these cracks was the product of several smaller cracks that had joined. The positions of some of the more significant origins are indicated in *Fig. 5*. AFTC2 was about 1.25 long by 0.84mm deep, AFTC3 was about 1.63 long by 0.67mm deep and AFTC4 was 1.75 long by 0.65mm deep.

Fig. 5 View of the surfaces of AFTC2, AFTC3 and AFTC4. Although each crack was treated separately here, the arrows that mark the more prominent origins indicate that each crack was made up of several small cracks that had joined.

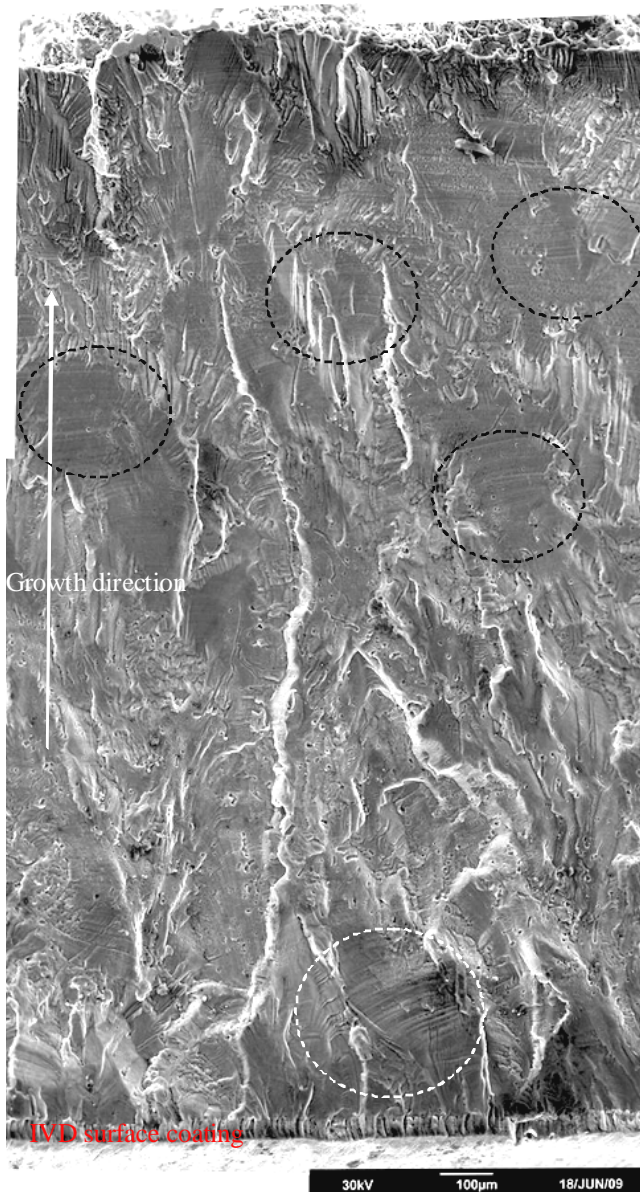
A scanning electron microscope montage of a section of the centre of crack AFTC1, from the surface of the flange to the end of the cracking is shown in *Fig. 6*. In this Figure it can be seen in the region encircled by the white dashed line that the crack progression marks appear to be spreading out as the crack gets deeper indicating crack growth rate acceleration. Whereas the areas encircled with black dashed lines appear to be growing at about the same rate.

Away from the origins, the surface of each of the cracks displayed well-defined fatigue progression markings. An examination of these markings on AFTC1 with the optical microscope revealed that there were many dark and light bands that were similar in appearance, and that these bands grew steadily further apart initially and, as indicated in *Fig. 6* were more evenly spaced towards the end of the cracking. Although the dark bands were randomly distributed in terms of the distance between each other, they were reasonably consistently spaced over the depth of the cracking, although some damage in the form of light corrosion (see below) to the crack surface up to about half the depth, see *Fig. 6* and *Fig. 7* did make the banding just before the end of this area more difficult to discern. The positions of the bands were measured to allow an indication of the crack growth against an

Fig. 6 A montage of a section of the centre of the AFTC1 crack, from the surface of the flange to the end of the cracking. In the region encircled by the white dashed line, the crack marks appear to be spreading out indicating acceleration, whereas in the areas encircled with black dashed lines, the crack appears to be growing at about the same rate.

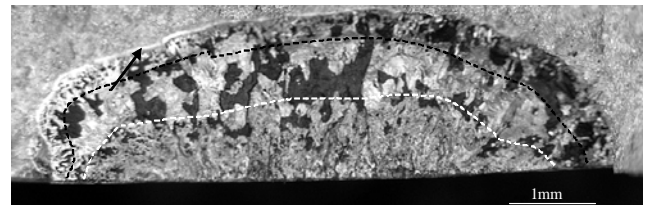
obvious corrosion markings. An inspection of AFTC1 revealed that there were a few prominent features that was thought to be related to down times rather than flight loading. It was hoped that these would help in pegging the crack growth curve to a time scale. The features are marked on Fig. 7 and they were more evident prior to cleaning the fracture surface. The features consisted of a region of light corrosion attack marks (up to the white dashed line on the Figure), an apparent boundary where the crack is deflected (black dashed line) and a clean band of growth at the end of the crack. The deflection is difficult to observe in a 2D representation so a topographical representation of a section of the crack is shown in Fig. 8. At the start of the crack's plane deflection, there was a narrow dark band of growth that appeared to have been darkened by environmental factors rather than the loading. It is postulated that this region may have been the result of a considerable period of down time since this is when these cracks would have been subjected to a humid hot environment (RAAF base Williamtown) for the longest uninterrupted period.

Fig. 7 A view of AFTC1 prior to cleaning showing an approximate boundary of light corrosion attack (white dashed line), the approximate boundary where the crack is deflected (black dashed line), see Fig. 8, and a clean band of growth at the end of the crack that appears in this picture as a thin bright line at the end of the fatigue crack.

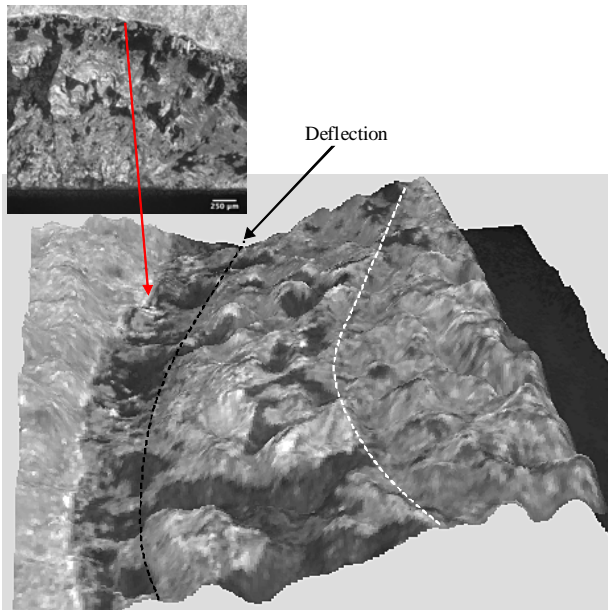
Fig. 8 A view of a section of AFTC1 prior to cleaning. The view is a topographical representation of the area of the crack's surface shown in the insert. The boundary of the extent of the light corrosion attack (white dashed line), the approximate boundary where the crack is deflected, preceded by a dark band (black dashed line) and a clean band of growth at the end of the crack (arrow) are marked.

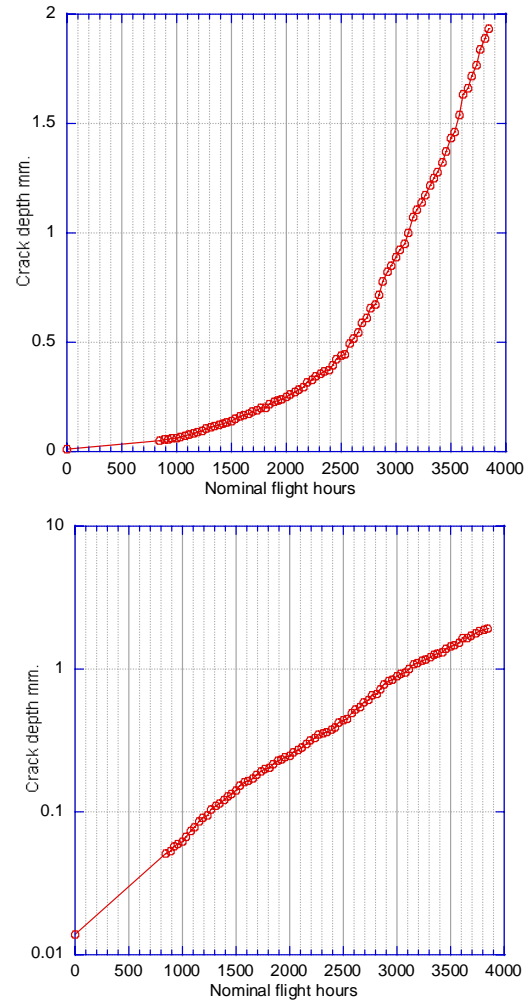
Quantitative fractography was performed for AFTC1 only. The crack's surface displayed well defined fatigue progression markings. An examination of these markings revealed that there were many dark and light bands that were similar in appearance, and that these bands initially grew steadily further apart, and as the crack grew larger they seemed to become more consistently spaced. These distinct groups of progression markings were measured, although the appearance of these markings did change as the crack grew deeper. Nevertheless, it was thought that the marks measured were made by similar loading events in service and were therefore representative of the growth rate of the cracking over time. The markings measured are plotted on both a linear and log crack depth versus 'events' plots in Fig. 9, using an initial measured discontinuity depth (etch pit from the IVD application process) and assuming that

cracking commenced when the stub entered service. The events have been scaled assuming a constant application of these events over the entire life of the stub against the reported flight hours (i.e. a repeated syllabus of mission types).

Fig. 9 The derived crack growth curves for the markings noted. These plots show the linear crack depth versus linear life and the log crack depth versus linear life.

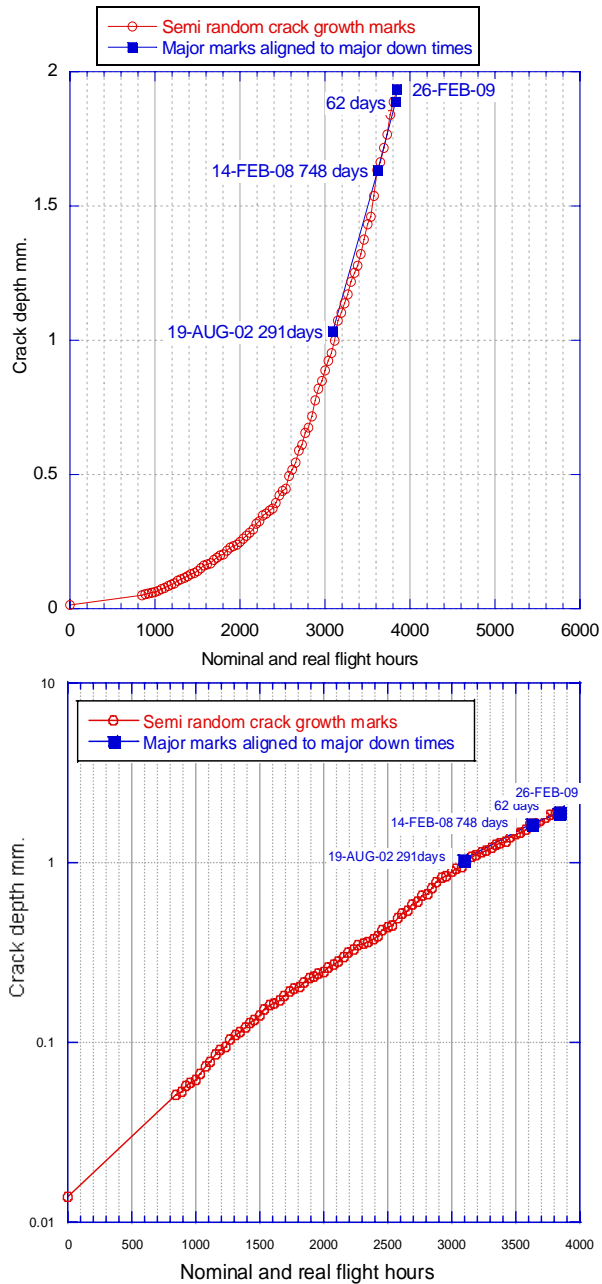
The flight hours subsequent to which the aircraft spent the longest down times during the life of the stub former were available. It is thought that during these periods moisture entered the cracks and caused corrosion or darkening of the crack's surfaces. Since these environmental effects appear to have caused some major marks on the crack surface (two of which are identified in Fig. 7) these were aligned to the longest down times: a 291 day down-time and a 748 day down-time. Finally, a 62 day down time was noted not long before

the removal of the Y598 former. It was most probable that the period following this down time accounts for the bright band of growth at the end of the crack. Placing these points on the crack growth curve gave the results shown in Fig. 10. An examination of these curves shows that the major marks when aligned to the major down times gave a good agreement with the proposed crack growth curve.

Fig. 10 The crack growth curve for the markings noted and the major marks aligned to the major down times. The agreement is good on both the linear and log representations.

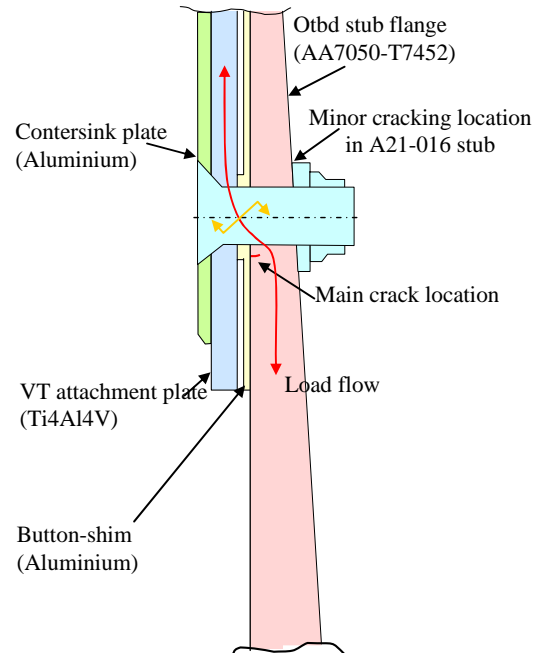
It appears that the early growth of the stub cracking associated with the fastener hole accelerated a little faster over the first few thousand hours of life and then almost stopped accelerating i.e. grew at a constant rate. It is consistent with loading that appears to be driving this cracking that is partially due to local bending via single shear transfer through the fastener: the schematic shown in Fig. 11 shows how the load travels through the fastener to the stub. A “button-shim” exists between the VT fitting and the stub and the thickness of the shim has a significant influence on the amount of bending that occurs, given that the interference fit fastener is correctly installed through the titanium and the aluminium parts. This loading along with the beneficial effect of the interference fit would explain why the cracking occurs away from the hole near the base of the shim.

Fig. 11 A schematic of the VT fitting to stub attachment at the lower fastener hole.
