FATIGUE LIFE ANALYSIS OF MAIN LANDING GEAR PULL-ROD OF THE FIGHTER JET AIRCRAFT

Marcin Kurdelski, Andrzej Leski, Krzysztof Dragan
Air Force Institute of Technology, Warsaw, Poland

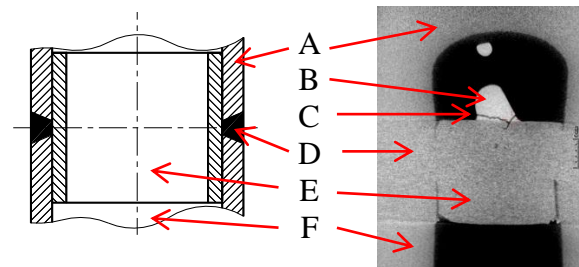
The component set-up (Fig. 2) for the welding process utilizes a steel alignment ring. The ring is attached to the pull-rod cylinder of the eye component by three spot welds that are evenly placed on the tube's circumference.

Fig. 2. Welded wiring diagram

A – pull-rod lower eye; B – spot welded seam; C – crack; D – welding seam; E – alignment ring; F – pull-rod tube

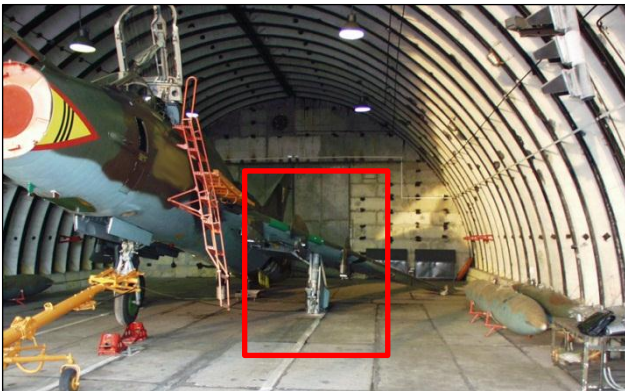
The problem described in the present paper concerns the pull-rod of the Su-22's main landing gear – a critical structural element [3]. The problem is related to two incidents, of which first (in 2005) was surprise for the operator. During a morning inspection of hangar buildings, the aircraft was observed lying in an untypical position (Fig. 3, 4). Preliminary visual inspection revealed a rupture of the pull-rod of the left main landing gear. After the inspection, the aircraft has been elevated and restored to a proper position and the damaged component was replaced. Subsequently, a detailed inspection of the landing gear has been carried out, as well as any needed repairs. After the repairs, necessary tests have been performed to verify landing gear's performance – such as retraction and extension tests, automatic braking systems tests, cockpit signalization systems test and others. Next step in the landing gear's inspection was the inspection of the torsion

Fig. 3. Failure of the main landing gear [3]

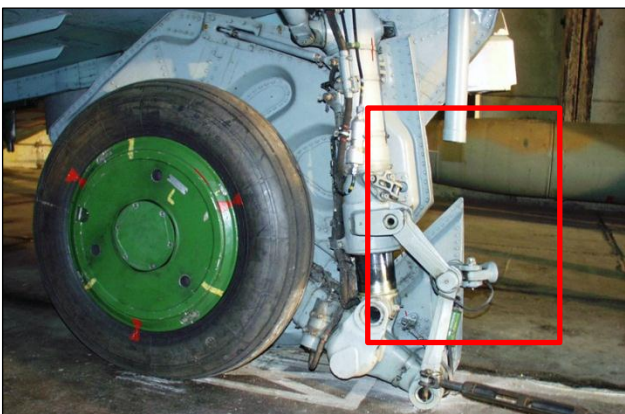
Fig. 4. Failed pull-rod [3]

Upon the Board's motion, inspection of the fracture surface was performed with the use of a magnifying glass (x5). The analysis of the fracture face's character enabled the Board to evaluate the usefulness of the color penetrant defectoscopy method as a means of preliminary

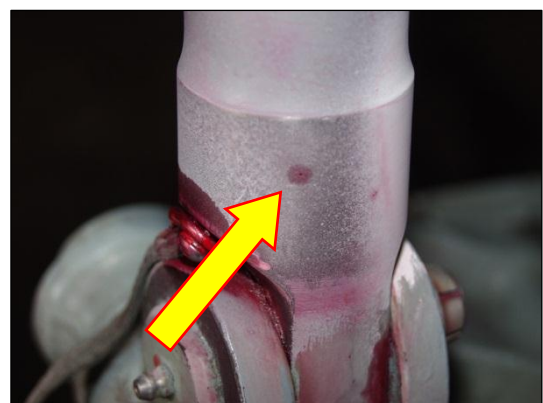
According to the instruction of the Investigation Board, tests have been performed on the rest of the fleet. The tests consisted of color penetrant defectoscopy (Fig. 5) analysis of the critical welded joint. In some cases doubts have been raised as to a particular pull-rod's structural integrity.

Fig. 5. An example of a defect in the welded joint area [3]

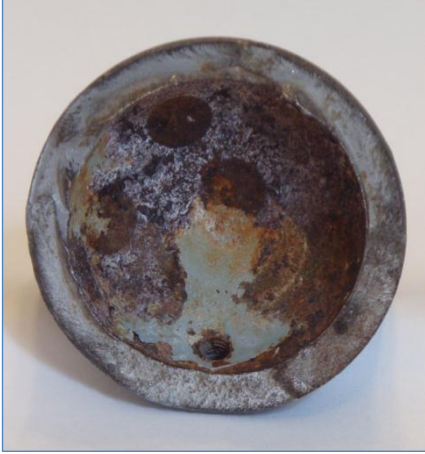
Although diagnostic tests were being performed since the incident, the problem re-emerged in 2010. Similarly to the earlier incident, a rupture of the pull-rod of an in-service aircraft occurred. As before, a few days after the last flight a rupture of the pull-rod elements took place. This time, the incident

happened on an aircraft that has been in service for 34 years/~1300 flight hours. In this service period the aircraft has performed about 1700 landings.

Fig. 6. Fatigue crack of the landing gear pull-rod

Both rupture cases seem to have many common characteristics, and the damage occurred in the same area. The occurrence of another pull-rod rupture in an in-service aircraft suggests that the countermeasures applied since the first incident were insufficient. In consequence, further actions have been carried out to determine the causes of damage. Also, NDI methods hoped to enable the detection of damage before the pull-rod ruptures have been revised and verified.

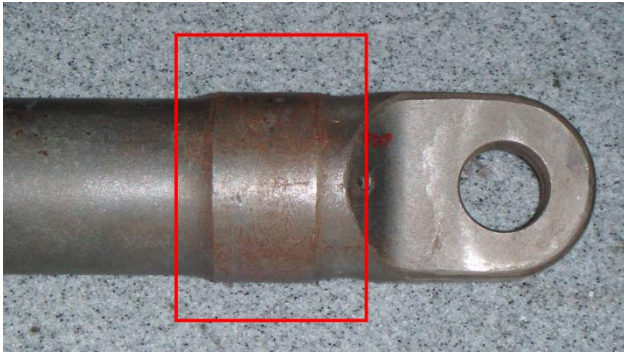
As a consequence of the 2004 incident actions have been undertaken with the aim of verifying of the currently serviced pull-rods. These actions were preceded with a research of the methods of inspecting the critical area shown in the illustration below [13]. Following NDI methods have been reviewed: the visual method, eddy-current, magnetic particle and the ultrasonic method. The review took into account any possible variants of failure modes, as well as the time and location of investigation. Based on this, conditions for conducting NDI have been specified.

As a result of the research reports made in relation to the rupture incident, inspections of the in-service pull-rods have been carried out with the following methods: visual, magnetic particle and ultrasonic. In all, 50 pull-rods from 25 Su-22 aircraft have been inspected. Three pull-rods had been classified as damaged and were ordered for decommissioning.

Fig. 12. Pull-rod critical area

In the case of performing the investigation *in situ* at the military base on an element installed on the airframe, the ultrasonic method has been specified as the most reliable. Utilizing the method necessitates however, that suitable crack test items are produced and the inspection probes are adapted accordingly. If a possibility of de-installing the pull-rod off the aircraft exists, utilization of the magnetic method inspection (performed on a stationary flaw detector) has been determined as the most suitable. This test should be reinforced with a visual inspection of the pull-rod. The magnetic particle method has also been mentioned if the flaws are searched for on the surface of the pull-rod. The magnetic particle method should also reinforce the inspection of the pull-rod tube's interior.

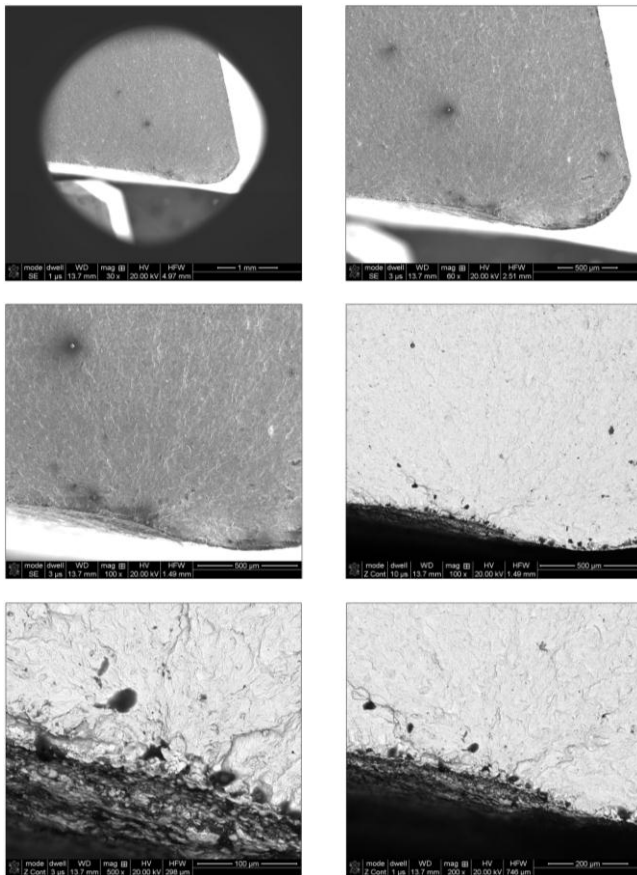
Fig. 15. Fatigue locus [15]

Figures above show that fatigue which occurred during the material tests was caused by the load sequence and shape of the specimen. There were no material defects found.

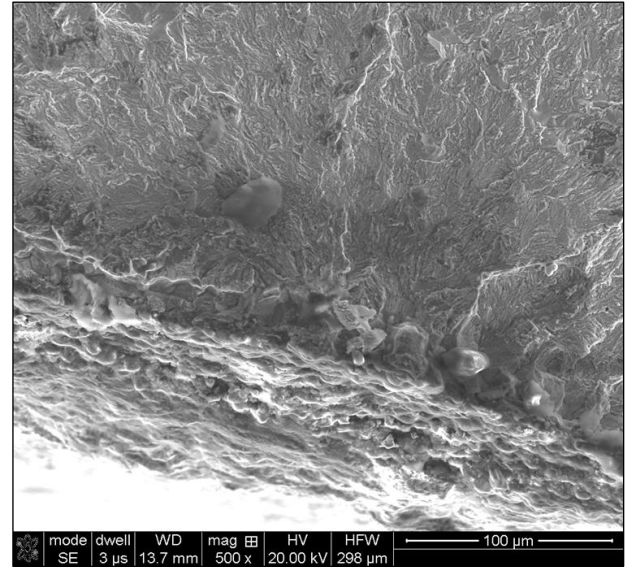
Fig. 16. Area of the crack [15]
