PRE-STRESSED MODAL ANALYSIS OF A TURBINE SPACER

M. Attia, J. Hou

**Air Vehicles Division, Defence Science & Technology Organisation (DSTO)
506 Lorimer St, Fishermans Bend, Victoria Australia**

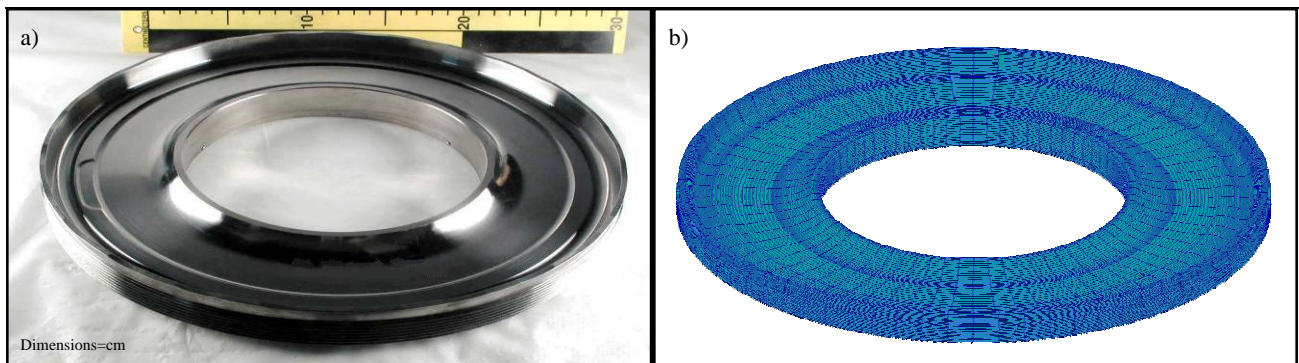
the 2D mesh of the spacer around the rotor axis by 360 degrees. Figure 2a shows the forward side view of the cracked turbine spacer whilst Figure 2b shows the 3D FE model.

Fig. 2. Forward side view of a) the cracked turbine spacer and b) the 3D FE model.

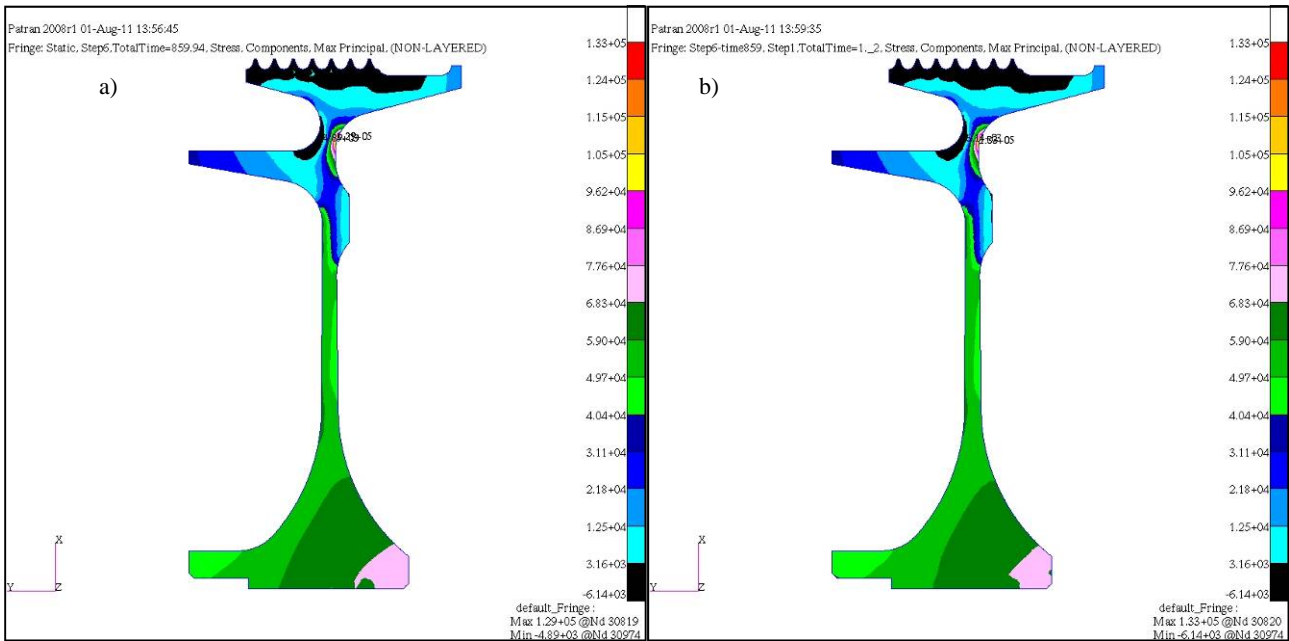
The comparison of the maximum principal stress results between the 2D spacer and the 3D spacer sub-model was made to evaluate the degree of accuracy of the 3D sub-model. As shown in Figure 4a and 4b, the stress distribution of the 3D case closely matched that of the 2D case. The difference in the peak maximum principal stresses was 3.1%

The peak stress of the spacer occurs at the forward outer web radius. Previous fractographic analyses by the OEM have shown that the forward outer web of the spacer is one of the common locations where cracks are found. However, the crack observed on this particular spacer was found at the forward outer rim. The stress contour plot in Figure 4b

indicates that the stresses at the forward outer rim area of the spacer were low under the examined operating condition. Therefore, it is unlikely that the crack at the outer rim was caused by steady-state centrifugal and thermal loading under the take-off power condition.

Fig. 4. Comparison of the maximum principal stress results between a) the 2D spacer (from the assembly model) and b) the 3D spacer sub-model (cross-sectional view).

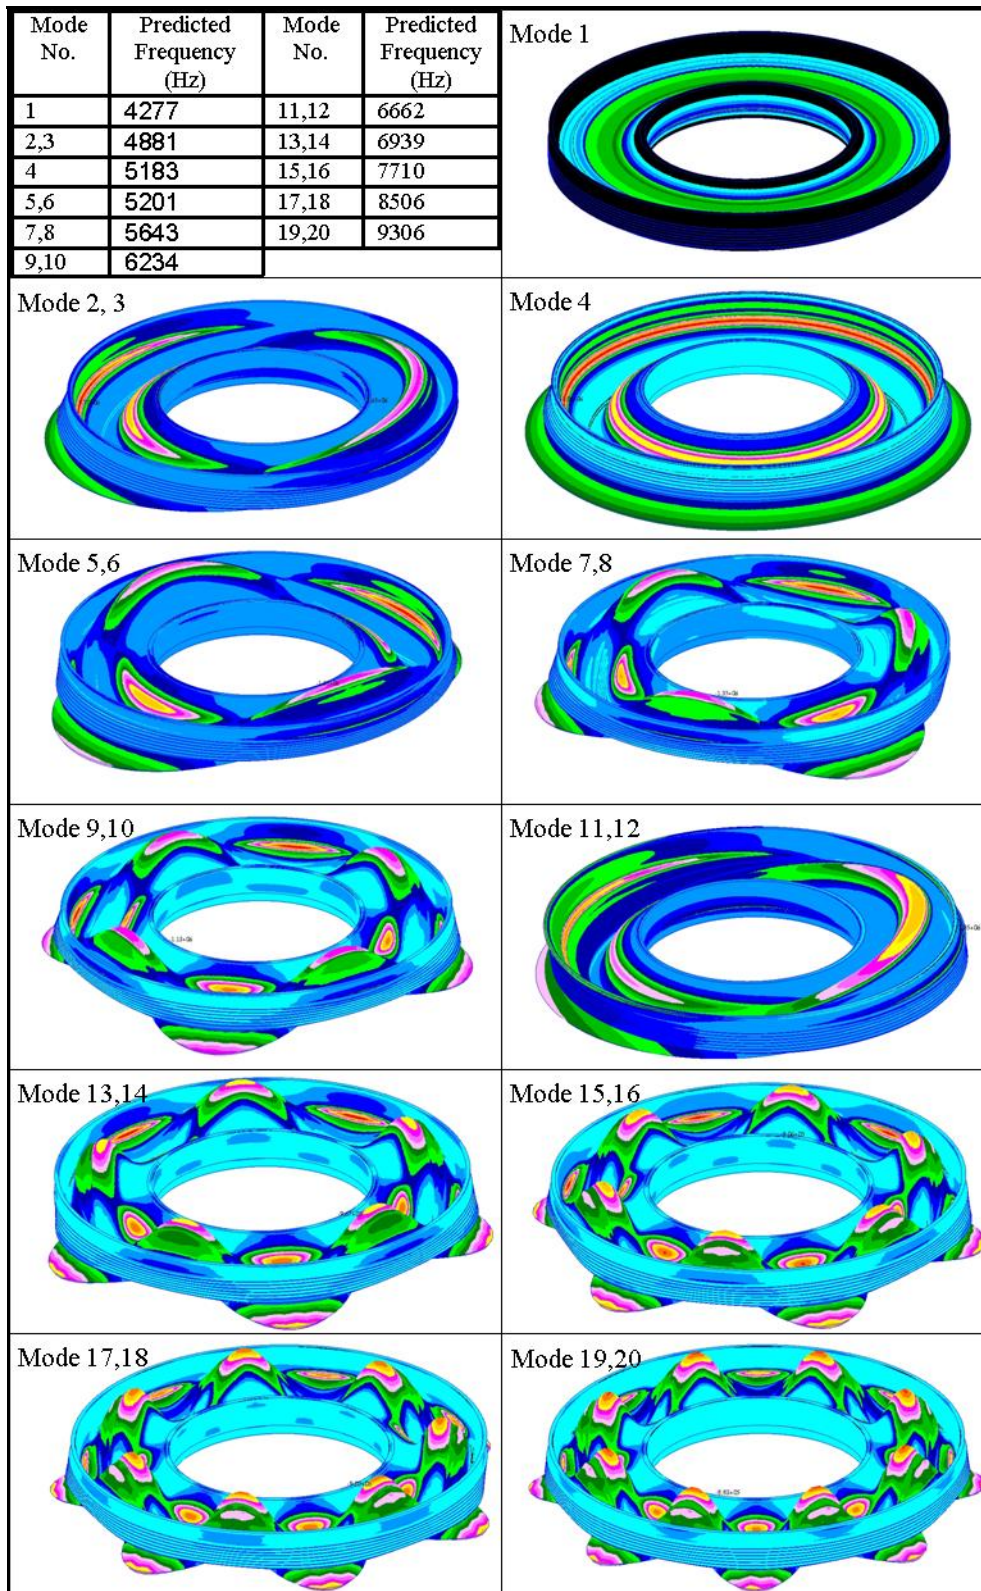
Figure 5 shows the relative stress distributions corresponding to the first twenty vibration modal shapes. The majority of these modes showed low dynamic stresses acting on the forward outer rim. Mode 1 showed high stresses at the inner radius of the spacer at the

mounting bore step. The majority of the modes (2-10 & 13-14) have high stresses occurring at the forward outer web radius. These results support why this region may be a common location where cracks can be formed if excitation sources are present. Modes 15-20, when excited, cause the spacer to experience high stresses at the aft inner web radius.

Modes 11 and 12, however, were found with high dynamic stress levels in the forward outer rim region. The stresses at these locations were not the peak stresses, however they were relatively high (70% of peak stress for these particular modes). It is possible that these modes could contribute to crack initiation at the forward outer rim location.

Fig. 5. Maximum principal stress distributions for the first twenty vibration modal shapes of the spacer.

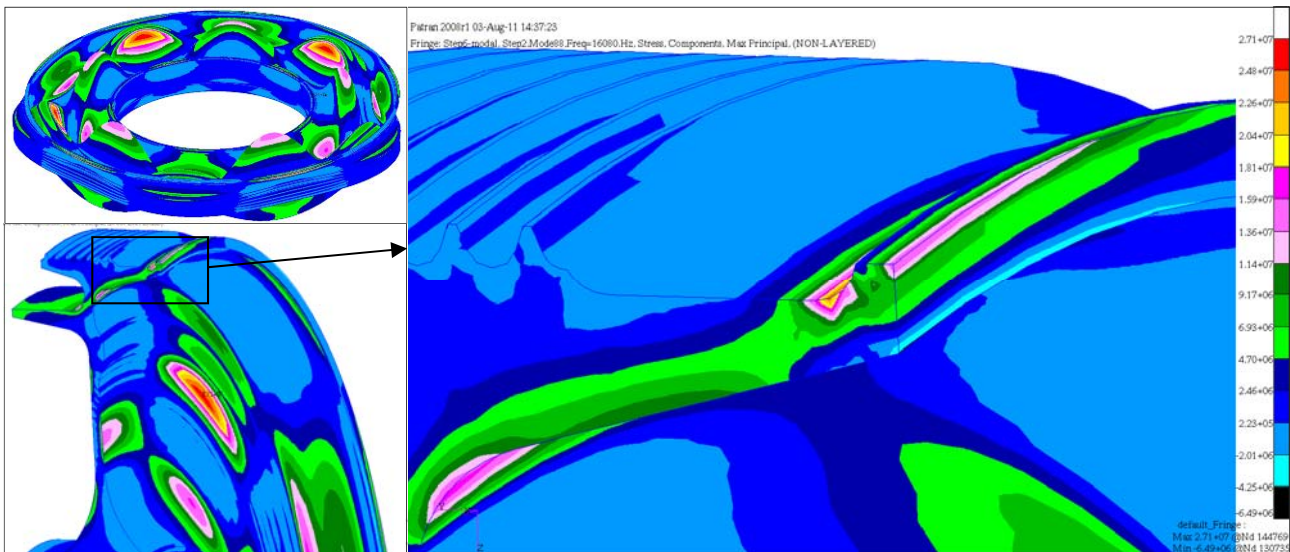
The remaining modes were examined and it was found that all had peak stresses at various locations around the spacer other than at the failure location. However, there were modes similar to modes 11 and 12 which resulted in high dynamic stresses at the forward outer rim region where the cracks were discovered; these modes are listed in Table 1. This table outlines the percentage stress at the forward outer rim relative to the peak stress acting on the spacer at each particular mode. The stress percentages outlined in Table 1 give an indication of how high the stresses acting at the region of interest actually are when compared to the peak stress at each mode.

The selected lower frequency modes outlined in Table 1 may be excited during engine start-up and shut-down and therefore might contribute to the crack initiation at the forward outer rim. However, these modes are unlikely to be the primary modes causing crack initiation as they are only excited over a very small period of time during engine start-up and shut-down. Modes 88 and 89 on the other hand are excited at frequencies close to the engine order excitation frequency of 16,584 Hz. These two modes, as depicted in Figure 6 are therefore likely to be excited at the engine's normal operating speed and therefore become a more likely cause of crack initiation.

Fig. 6. Max principal stress distributions corresponding to vibration modal shapes 88 & 89.

It is recommended that vibration modes under other operating conditions be examined in order to determine if other crack failure modes are excited during engine operation. It could also be beneficial to include the presence of scallops at the forward rim for a more complete stress analysis.
