A320 FULL SCALE STRUCTURAL TESTING FOR
FATIGUE AND DAMAGE TOLERANCE CERTIFICATION
OF METALLIC AND COMPOSITE STRUCTURE

B. Brandecker and R. Hilgert
Stress Department
Messerschmidt-Bölkow-Blohm GmbH
Hamburg, Federal Republic of Germany

Abstract

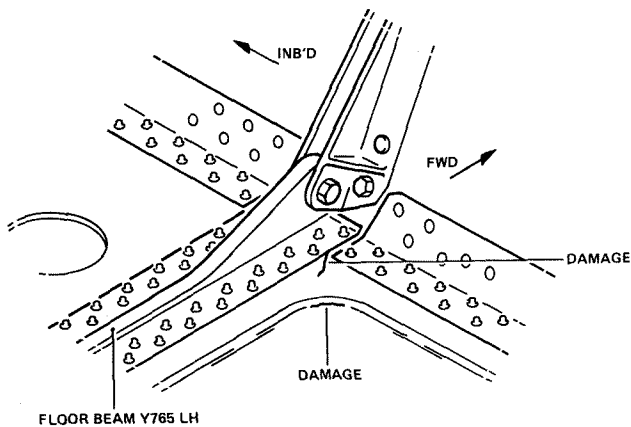
An example of one damage caused by constraint deformation is shown in Figure 8.

Figure 8: Fatigue Damage in Pressure Deck Membrane at Frame 42

A corner crack had been found in the diaphragm initiating at a rivet hole due to local buckling caused, by constraint deformation. This damage, found at 16 765 flights, led to a modification consisting of reinforcing the diaphragm itself by increase of thickness, installation of an additional tapered support in the concerned corner and cold expansion of rivet holes. This modification was introduced on all A320 aircraft before delivery and also to the EF2 test specimen showing no damages once more.

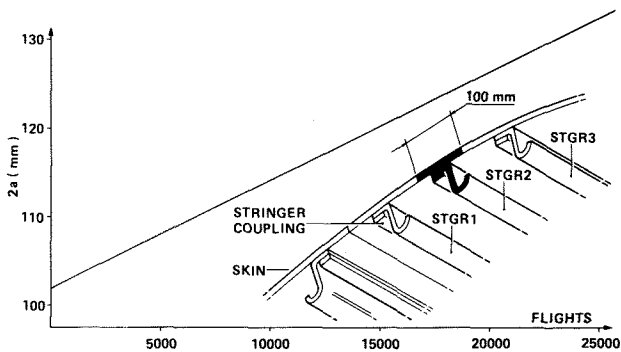
Figure 11: Artificial Damage at Circumferential Joint, Upper Shell

A 100 mm circumferential skin crack was installed in the stringer coupling area at Frame 47 near crown center line above a cut-through stringer and coupling. The goal of this test is to show the efficiency of external detailed visual inspections as defined in the structural inspection program. The crack propagation, observed over a period of approx. 25 000 flights, was slower than predicted using uni-axial stresses in calculation. The difference is small in case of consideration of bi-axial stresses.

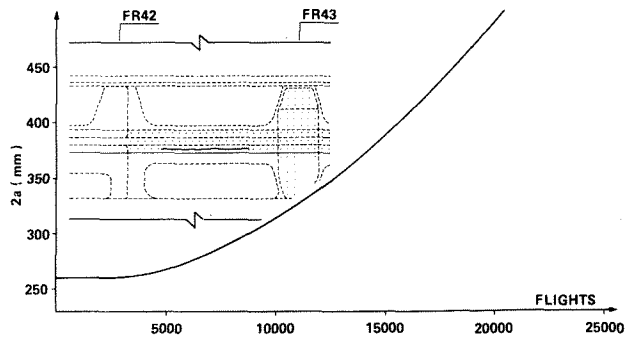
Longitudinal Joint. Figure 12 shows the design of a typical A320 longitudinal lap joint and the location of the crack retarders installed at each frame intersection.

The goal of this test was to verify predicted crack growth behaviour in the inner panel lower rivet row and the intended crack turning effect in crack retarder area which allows external visual inspections of a previously hidden crack. To date the crack turning is verified and the crack propagation

is slightly slower than predicted using earlier experience from similar design features and A300 and A310 aircraft. The small differences can be explained by the different stiffness rate at A300/A310 and A320 aircraft.

Figure 12: Artificial Damage at Longitudinal Joint, Inner Panel Lower Rivet Row

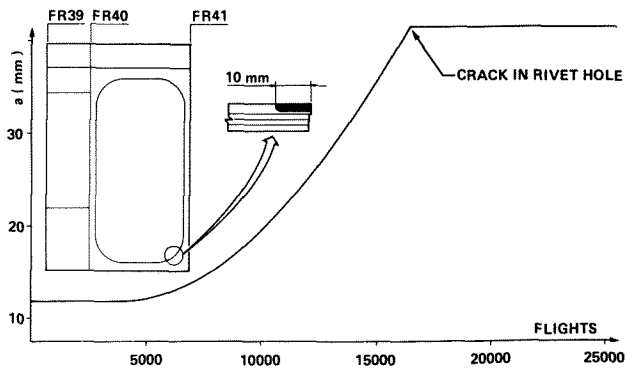
Figure 13 gives design details of the highly stressed aft lower cut-out corner.

Figure 13: Artificial Damage at Emergency Exit Cut-Out, Skin Panel

The crack is installed in the skin panel which is above three corner doublers. This crack is of special interest since the stress intensity at the tip end is highly influenced due to stress redistribution caused by the undamaged doublers. To date an acceptable correlation between test and calculation is noticed. However, further comparisons are necessary up to the end of the test because of the increased influence of the intact doublers on the stress intensity.

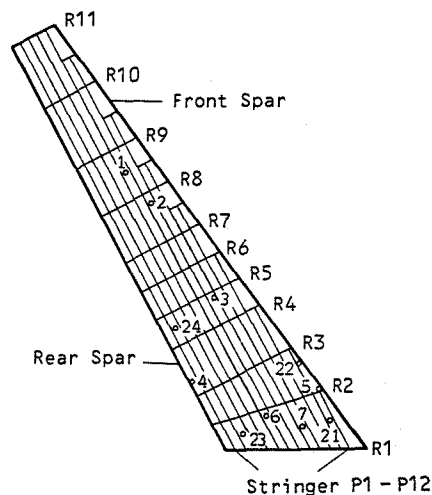
Figure 16 shows the position, energy level and damage sizes of the 24 impacts on the right fin box skin panel.

Impact No.	Diam. (mm)	Laminat (mm)	Energy (J)	Damage	
				visible	NDT (mm ²)
1	12	1.5	13	230	635
2	50	1.5	12.1	250	1257
3	12	4.1	13	44	868
4	12	5.6	20.2	no	1360
5	50	6.5	17.8	no	720
6	12	7.0	19	no	1400
7	12	3.7	13	no	665
21	12	6.7	40	20	2700
22	12	5.7	40	40	2045
23	12	7.5	40	20	2070
24	12	6.5	40	13	1815

Figure 16: Impacts on right Skin Panel of Torsion Box

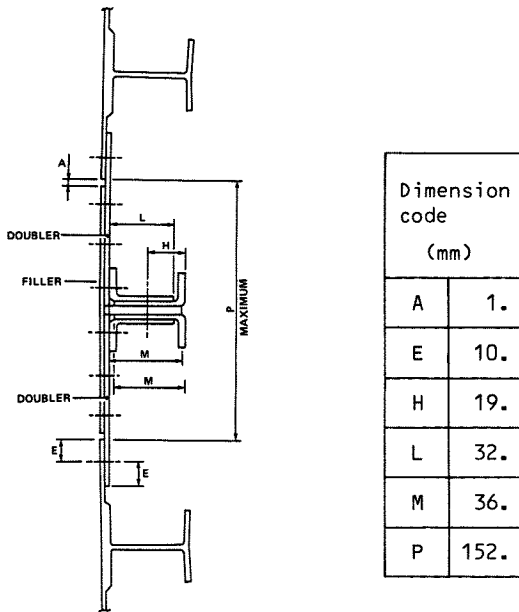
Figure 17: Skin Stringer Rivet Repair with Precured CFRP Sections

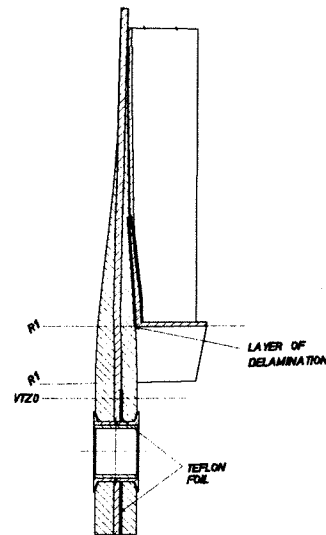
After accumulation of 37496 test flights the test was stopped, due to a damage at the left main attachment fitting of the front spar. The damage was caused by delamination of the root rib connecting angle (see Fig. 18) from the main fitting. Subsequently, this delamination caused several delaminations in the fitting laminate until the load introduction section of the fitting failed.

Figure 18: Delamination of the Rib 1 Connecting Angle

The investigation of the damage revealed that the bonding of the root rib connecting angle and the fitting was overloaded by the transverse reaction force of the main fitting. Consequently an additional rivet line, connecting the root rib angle with the main fitting and skin panel was introduced as serial solution and retrofitted in the full scale test component. Additionally the damaged section of the EF5 test component was cut out

and replaced by a new one. The new section was riveted by means of inner CFRP doublers and countersunk rivets to the parent structure like a flush rivet repair.

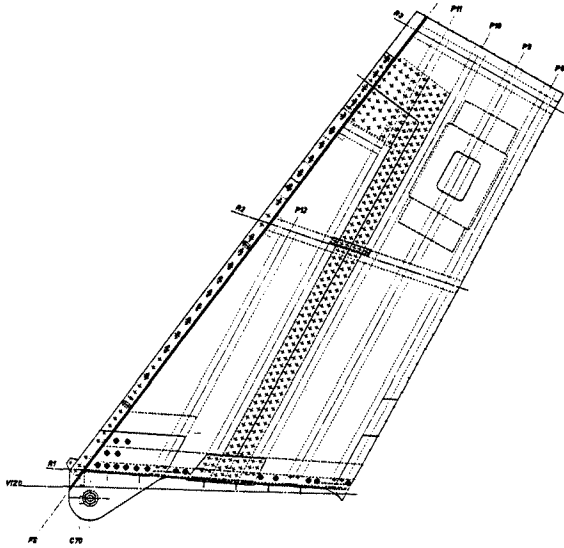
Figure 19: Repair due to the Front Spar Main Attachment Failure

Due to the replacement of the damaged section the test program was extended by 37496 flights to validate the new main attachment section for 1.5 lives. After the repair a limit load test with the decisive load cases was conducted to prove the rivet repair, and finally the fatigue test was continued up to 48400 flights.

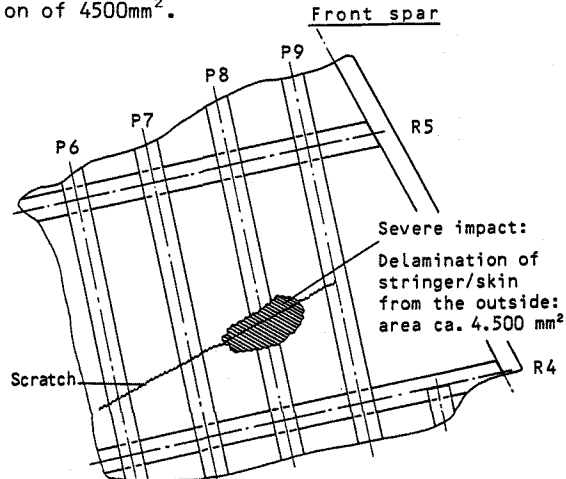
Lightning strike damages derived from lightning strike tests were introduced into the torsion box and rudder upper part. A severe impact, delaminating one stringer from skin caused a total delamination of 4500mm².

Figure 20: Severe Impact at Stringer P8
