AN EXPERIMENTAL METHODOLOGY FOR EVALUATING SURVIVABILITY OF AN AERONAUTICAL CONSTRUCTIONS FROM COMPOSITE MATERIALS

Bosko Rasuo University of Belgrade, Yugoslavia

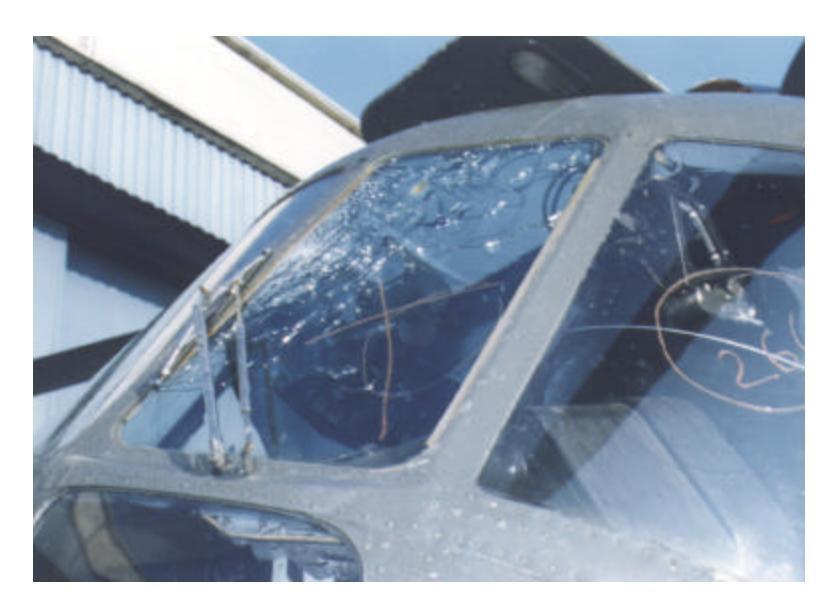
Figure 2. Ballistic damages of helicopter's windshield.

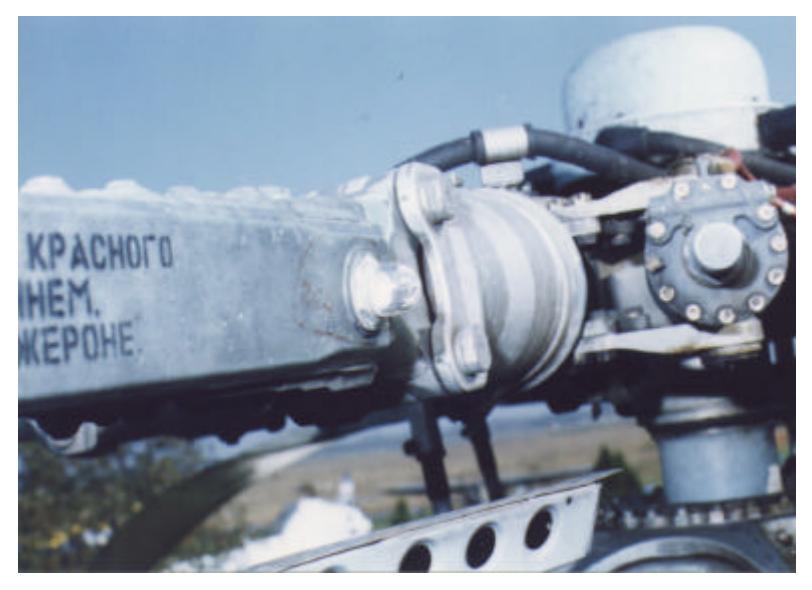
Figure 4. Ballistic damages of transmission and main rotor head.

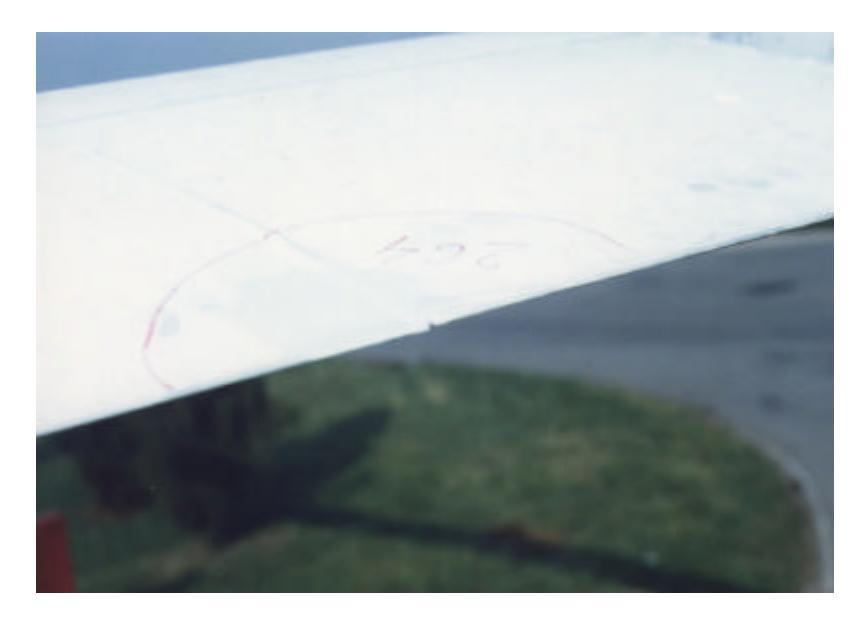
Figure 3. Ballistic damage of the main rotor blade.

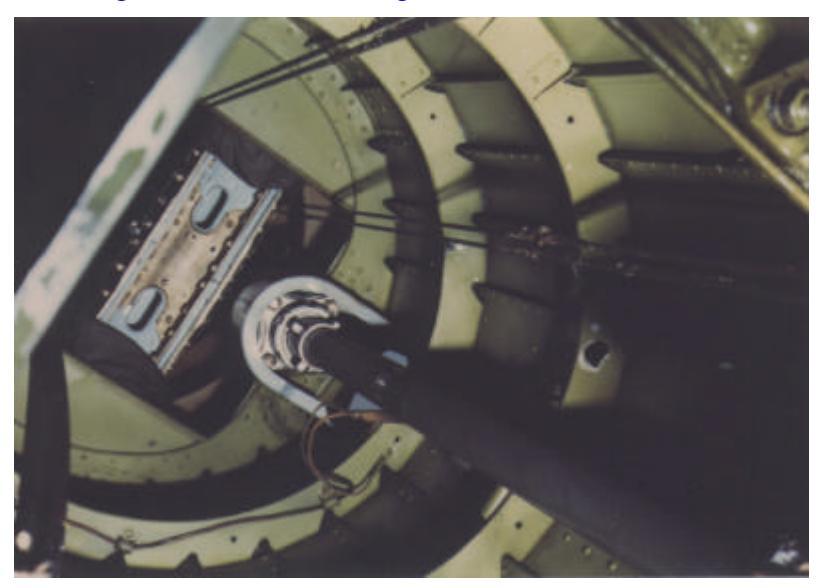
Figure 6. Ballistic damages of the tail rotor drive shaft and vicinity structure.

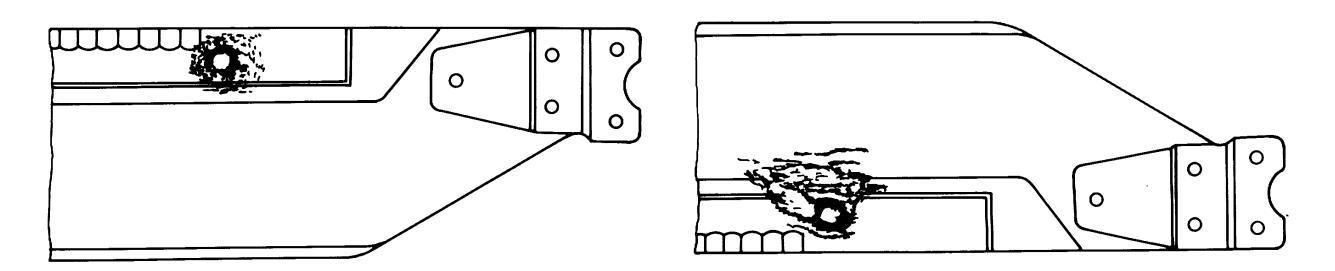
The resulting damage together with its ingoing and out-going penetration presents a vital structural damage on the load carrying part in the area usually exposed to heaviest loads. The investigations were carried out on both tail rotor blades follow a standard practice used by majority of scientific and research aeronautical institutions [12-14].

Fig. 8. The helicopter tail rotor blade made of composite laminated materials after ballistic damage made by the bullet of 7.9 *mm* calibre shoulder weapons, in-going (left) and out-going (right) penetration.

In the course of those investigations the behaviour of the blade, particularly of the damaged parts, was closely followed. No further damages or delamination of the structures, i.e. no further changes were observed at the damaged areas in the course of the testing itself.

When the fatigue testing program was finished on both non-damaged and damaged blades, further detailed check-ups on the deformation and degradation of geometrical shape of the blades and delaminations were carried out. On that occasion no changes were observed on either type of the blade. Also no delamination was observed and the damaged areas of the blades were not expanded in any way.

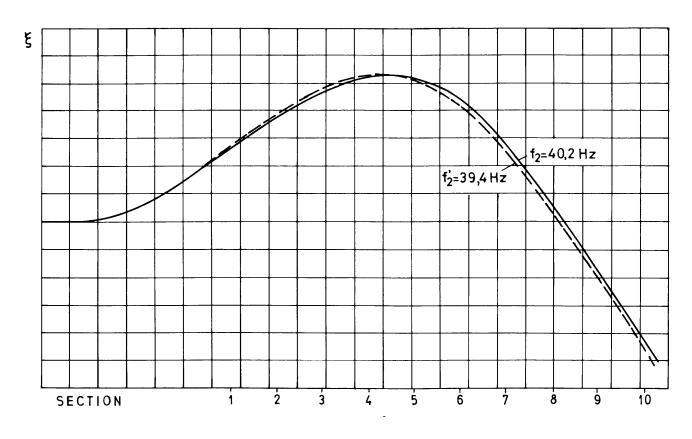
Fig.10. The second oscillation mode for both non-damaged $(f_2=40.2 \ Hz)$ and damaged $(f_2=39.4 \ Hz)$ tail rotor blade.

The vibratory testing results were surprisingly the same for non-damaged and damaged heavy transport helicopter tail rotor blades. The differences in frequencies obtained and displacement vectors for some basic types of oscillation were within the range 2-5 %. The structural damping results coincided to even higher degree and the differences in the logarithmic decrement and Q-factor were less then 2 % (Figure 12). These minor differences in basic dynamic characteristics of nondamaged and damaged helicopter tail rotor blade made of composite laminated materials cannot significantly change or endanger the helicopter flight security.

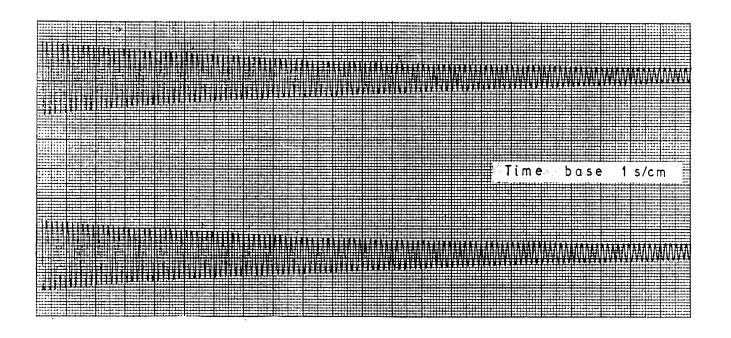
The original records obtained from these tests for non-damaged and damaged tail rotor blade at the measured cross-section 10 with time base 1 *s/cm* are shown in Figure 11.

Fig.11. Structural damping for both non-damaged and damaged tail rotor blade.
