PROGRESS ON AIRCRAFT INTEGRATED SAFETY HEALTH ASSESSMENT (AISHA)

H. Pfeiffer¹, F. Fransens², W. Hillger³, U. Pfeiffer³, M. Wevers², Ch. Buelens¹

Keywords: *Structural health monitoring, ultrasonic, Lamb wave, maintenance, sensor network*

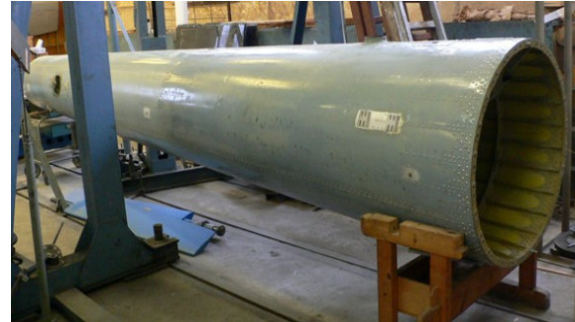
Fig. 2 Beam of a MI-8 helicopter selected for full-scale fatigue tests

For the upcoming full-scale tests, helicopter beams made of aluminium (Fig. 2) and composite were selected which enable to validate the results that were previously obtained in the lab scale experiments.

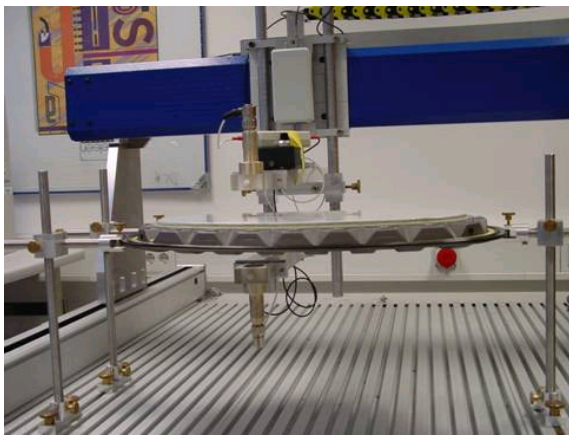
Fig. 3 Scanner system of the HFUS 2400 AirTech

For the visualisation of the Lamb wave fields (Fig. 3) and their interaction, one actuator at a fixed position on the bottom of the specimen has been used as a transmitter. A second PZT-patch is coupled by a water film to the surface and moved by an XY- scanner in a meander track.

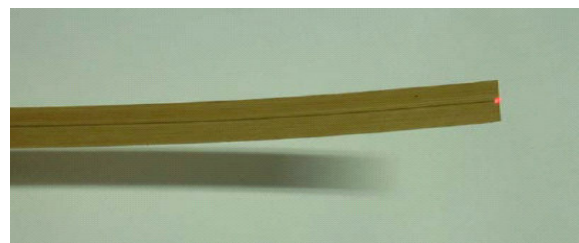
Fig. 4 Single mode optical fibre sensor (SMARTape) [11]

The optical fibre sensor (Fig. 4) is connected to a stabilised laser source which sends light (wavelength = 1310 nm) into the sensing fibre. The photo diode detection unit is coupled to a preamplifier and a filter/amplifier transmitting the filtered and amplified signal to an oscilloscope, and a PC-controlled read-out unit where it will be processed and analysed.

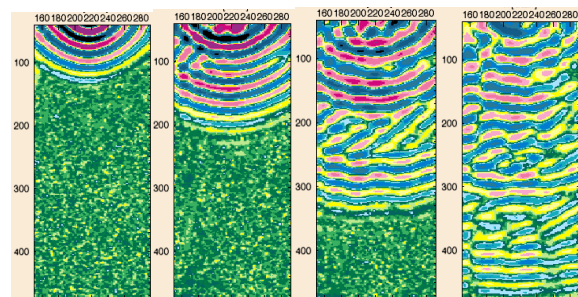
Fig. 6 Lamb wave propagation in sandwich specimen (impacted with energy of 15 J)

Fig. 6 presents four snap-shots out of an animation calculated out of a full wave data set of a Lamb wave testing of a sandwich panel [12]. The snap shots present the propagation 203, 331, 555 and 779 μ s after excitation. The first image shows undistorted propagation, but after 331 μ s first interference between edge reflected and the primary propagation wave is indicated on the left hand side.

Further interferences can be observed in the following images. The snap shot after 779 μ s clearly indicates several interferences between the propagating wave in the centre and reflections from the edges (Fig. 6). This is the reason why different sizes of damage do not always result in differences between the received signals.

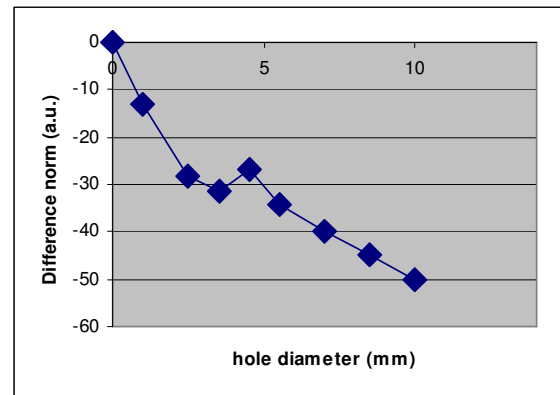
Fig. 8 Lamb wave response determined by piezoelectric patches as a function of increasing size of an artificial hole in an aluminium sheets

A similar experiment was performed by using two disk-like PZT patches which were adhesively connected to the aluminium sheets. After recording of a reference waveform of the undamaged sheet, holes with increasing diameter were drilled and the corresponding

change of Lamb wave response was recorded and analysed (Fig. 8).

It was found that the norm (which is proportional to the RMS value) of a specified time-gated waveform decreased with increasing diameter. This can be explained by the material loss and by a change of the interference pattern. The interference pattern is also responsible for the small maximum at about 5 mm. It corresponds to a fracture of the incident wavelength and a certain constructive interference effect takes place.
