THE INFLUENCE OF CORROSION TREATMENTS ON FATIGUE OF AIRCRAFT STRUCTURAL JOINTS

Aditya Jaya, Ung Hing Tiong, Reza Mohammed, Cees Bil, Graham Clark
School of Aerospace, Mechanical and Manufacturing Engineering, RMIT University,
Bundoora, 3083, VIC, Australia

Abstract

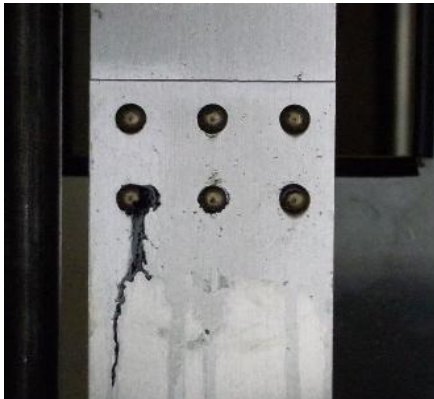
Fig. 2. (a) LPS-2 treated specimen; (b) LPS-3 treated specimen.

It was noticed that 24 hours might not provide enough time for LPS-2 to dry out. Observation on the specimens treated with LPS-2 suggested that even 2 days after application, the CIC was still in liquid form, as indicated by a black trail that appeared during the fatigue test of the specimens as shown in Fig. 2(a). Similar observations have been reported for real aircraft applications. Unlike LPS-2, a 24 hour period was enough for the LPS-3 to dry out as shown in Fig. 2(b).

For LPS-2 treated specimens, the fretting debris was spread across the faying surface and concentrated between the rivet rows, presumably because of the lower clamping force at that region. To some extent, fretting product was also carried by the CIC away from the faying surface as shown in Fig. 2(a); this removal could also affect the process.

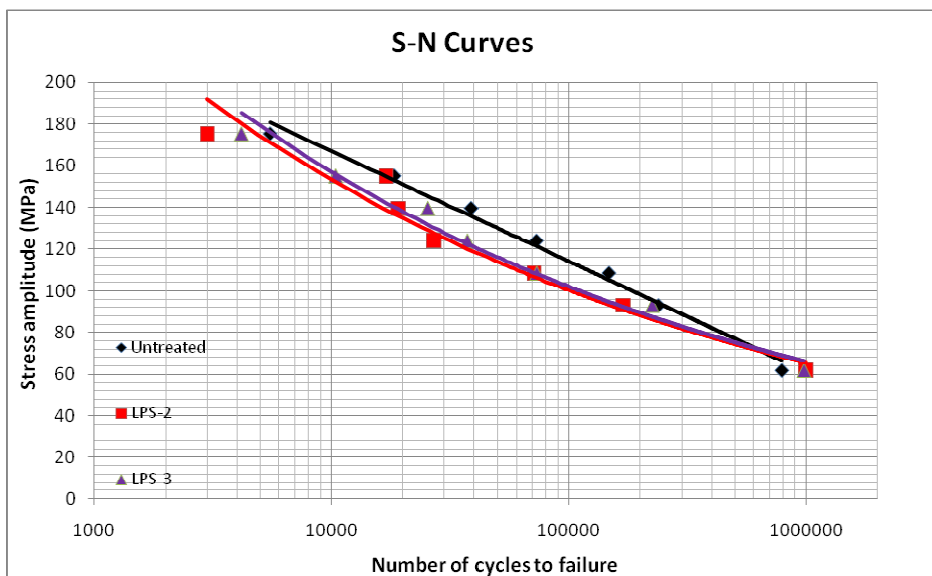
Fig. 3. S-N curves of treated and untreated specimens.

The fatigue lives of tested specimens were plotted in S-N curves shown in Fig. 3. Using the fitted curves, it was observed that at the high load level, the fatigue lives of treated specimens were slightly lower than the untreated specimens. Descending into the intermediate load level band, however, a progressively greater life reduction factor - of two or more - was observed for treated specimens. At low load levels, there was also a reduction in fatigue lives of treated specimens, although the reduction was small at the lowest load levels tested. The exact extent of the change at the lowest load level is still somewhat uncertain, since the results include a run-out result on a specimen treated with LPS-2; that will be explored further in additional tests.

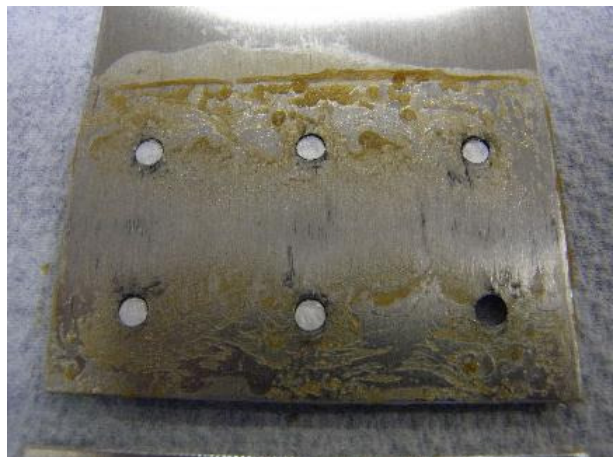
Fig. 4. LPS-3 treated specimen tested at 11.3kN.

When the highest load (i.e. 11.3kN) was applied, the shear stress acting on the rivets caused the rivets to fail in shear, identified by the flat, clean fracture surfaces of the rivets shown in Fig. 4.
