## SPD REPAIRS TO THIN ALUMINIUM STRUCTURES

**R. Jones\***, **N. Matthews\*\***, **J. Elston\***, **K. Cairns\***, **J. Baker\***, **B. Wadsley\*\*** and **S. Pitt\***  
 \* DSTO Centre of Expertise in Structural Mechanics, Department of Mechanical and Aeronautical Engineering, Monash University, Wellington Rd, Clayton, Vic 3800, Australia., \*\* Rosebank Engineering, 836 Mountain Highway, Bayswater, VIC 315  
[rhys.jones@monash.edu](mailto:rhys.jones@monash.edu), [neil.matthews@rosebank-eng.com.au](mailto:neil.matthews@rosebank-eng.com.au)

*This paper discusses repairs and modifications to thin load bearing aircraft structures using Supersonic Particle Deposition technology, a topic which is currently under consideration by both the Australian Naval Aircraft Systems Project Office (NASPO) and the RAAF Directorate General Technical Airworthiness (DGTA). Ensuring continued airworthiness is of paramount importance and it is essential that (aircraft) structural integrity be maintained after repairs have been installed. To this end the present paper summarises the results of a series of experimental studies into the ability of SPD doublers to extend the fatigue life of thin aluminium

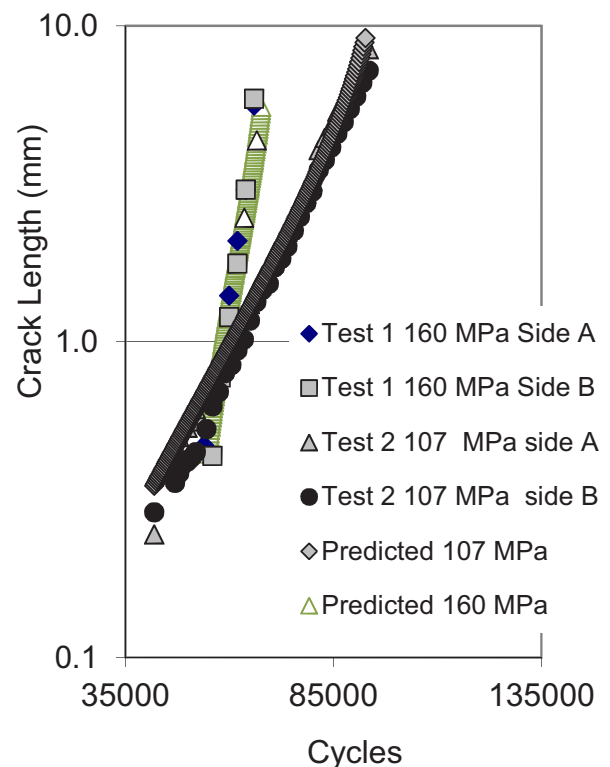
Figure 8 Measured and predicted crack length histories.

To evaluate this we tested two 1.27 mm (thick) x 76 mm (wide) 2024-T3 aluminium alloy SENT (single edge notch tension) specimens. The specimens, which were tested in laboratory air at a frequency of 5 Hz, had a small 0.5 mm semi-circular notch from which the cracks grew. The first test had a maximum stress  $\sigma_{max} = 160$  MPa and  $R = 0.1$ . In the second test we had a maximum stress  $\sigma_{max} = 107$  MPa and  $R = 0.1$ . The smallest through-the-thickness crack analysed in this study was approximately 0.29 mm. The resultant crack growth histories are shown in Figure 8.

The resultant predicted crack length histories are shown in Figure 8 where good agreement between the measured and predicted crack length histories.

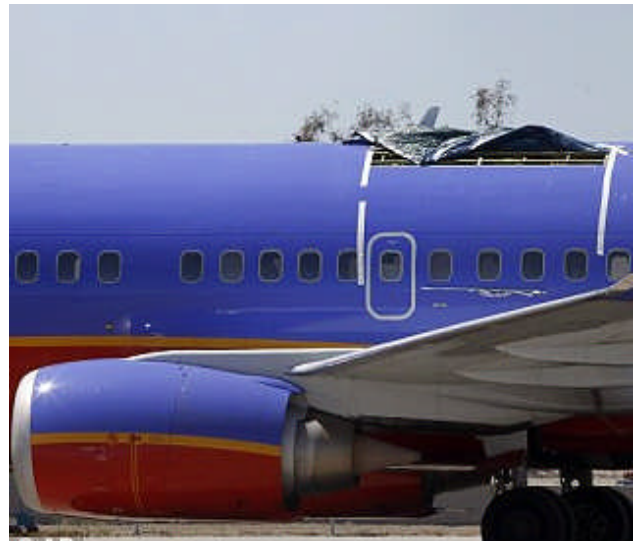
Figure 11 Tarpaulin covering the five-foot-hole that ripped open in the roof, from [16].

The extent of the problems associated with fuselage lap joints is aptly illustrated by the April 2011 incident whereby cracking in the fuselage lap joint in a Southwest Airlines Boeing 737-300 aircraft resulted in a large 5 foot hole in the roof, see Figure 11.

This incident led to the grounding of 79 of its older Boeing 737 aircraft [16] and to the cancelation of almost 700 flights. Subsequent inspections, which found cracks in a total of four Southwest aircraft, [16] led to the US FAA mandating the inspection of 175 Boeing 737 aircraft that had seen more than 35,000 cycles. The problem of cracking in fuselage lap joints is not confined to Boeing 737 and 727 aircraft. On 26th October 2010 an American Airlines 757-200 aircraft was forced to land at Miami International Airport due to a sudden decompression arising from cracking in a fuselage joint [17]. This aircraft had experienced less than 23,000 cycles. This led to the discovery of cracking in other 757 aircraft and a subsequent January 2011 FAA Airworthiness directive [17] mandating the inspection of all 757-200 and 757-300 aircraft.

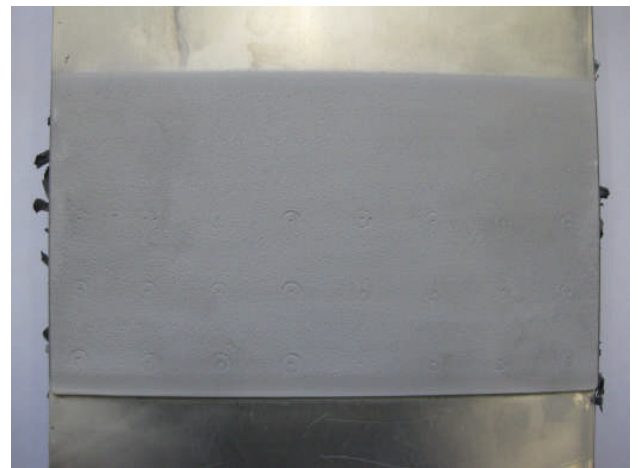
Figure 16. Close up view of theregion with the SPD covering the specimen.

To illustrate increase the LOV of the joint a 1 mm thick 7075 SPD doubler was deposited over the three rows of fasteners, see Figures 15 and 16, and the specimens tested as above. This test program revealed that after approximately 110,000 cycles the SPD doubler was still intact. Furthermore, there was no apparent crack growth at any of the fasteners in the lap joint, cracking in the SPD or damage to the bond between the SPD and the skin/fasteners. If we take the LOV to be the time to first linkup then this corresponds to more than a 3.3 fold increase in the LOV, depending on how the LOV is defined.
