AN EXPERIMENTAL METHODOLOGY FOR EVALUATING SURVIVABILITY OF AN AERONAUTICAL CONSTRUCTIONS FROM COMPOSITE MATERIALS

Bosko Rasuo University of Belgrade, Yugoslavia

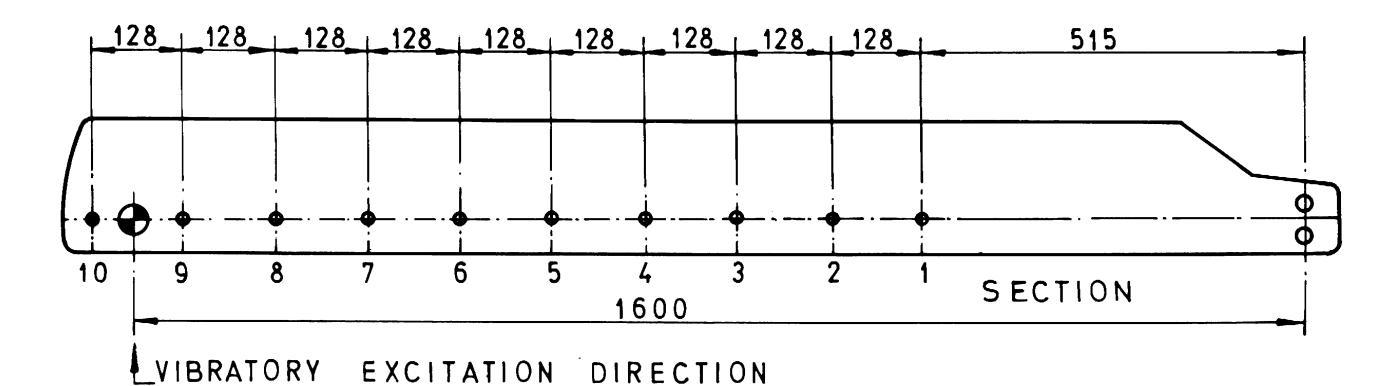
For displacement measurement in these investigations piezoelectric accelerometers were used and they measured displacements at selected points on the blade as shown in Figure 7.

Fig. 7. Measurement points in vibratory testing.

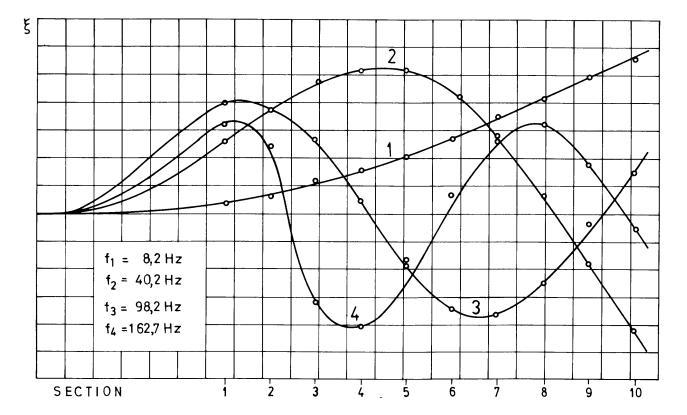
Having determined the frequencies for the first-four harmonic's natural (resonant) modes of oscillations, displacement vectors for the first-four basic oscillation modes were measured. Some measurement results are shown in Figures 9 and 10. Figure 9 shows the harmonic analysis results of the first-four oscillation harmonics for the non-damaged tail rotor blade, while Figure 10 gives us a comparative presentation of the second oscillation mode for both non-damaged and damaged tail rotor blade.

Fig.9. The natural modes of oscillation for the non-damaged tail rotor blade.

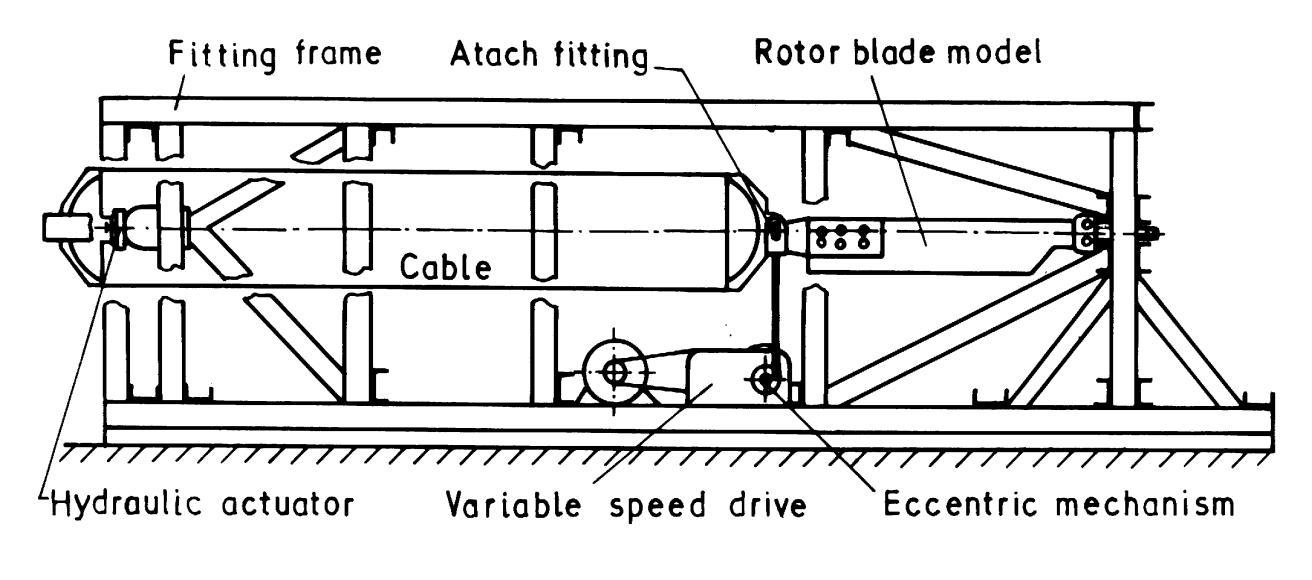
Fig. 13. Tail rotor blade fatigue test facility.

system with oil lines and a pump with a servomotor and control manometer was used as the centrifugal force generator. Its maximum force was 40000 *daN*. Thanks to this system the basic functioning of the facility frame became automatic.

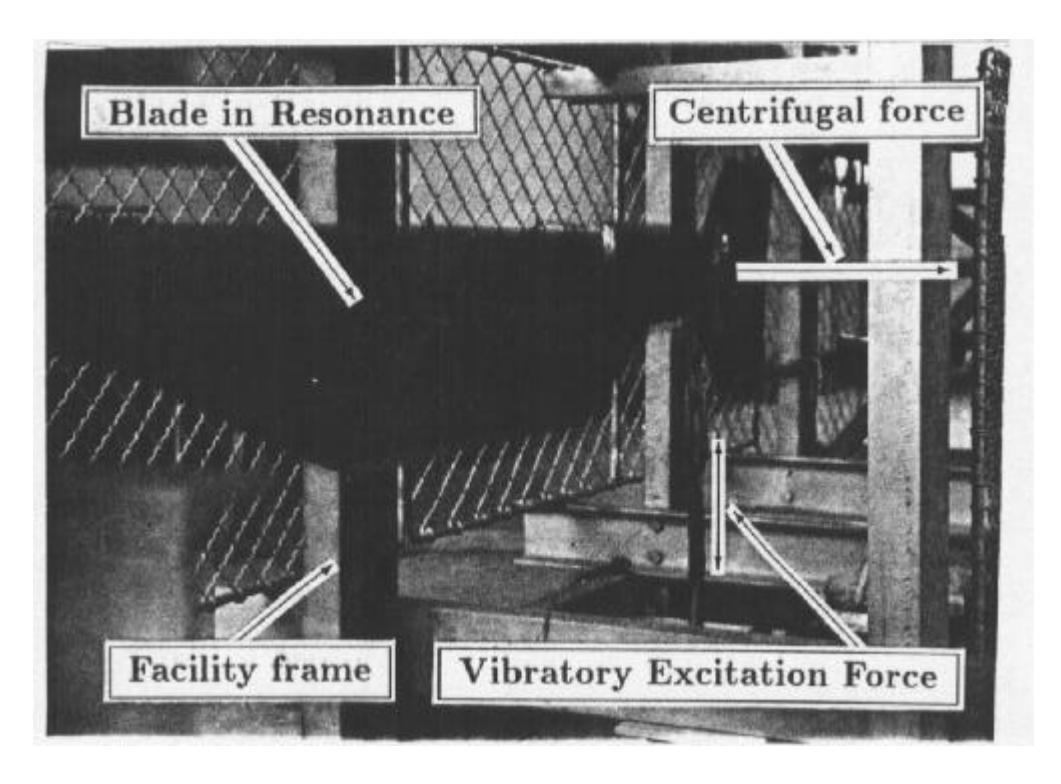
In the course of those investigations the behaviour of the blade, particularly of the damaged parts, was closely followed. No further damages or delamination of the structures, i.e. no further changes were observed at the damaged areas in the course of the testing itself.

The results of the damaged tail rotor blade fatigue testing have proved that even thus severely damaged blade is capable of performing all its vital functions on the helicopter even after 65 working hours in extremely difficult flight conditions.

Fig. 14. Rotor blade in fatigue testing.
