PLATFORM SUSTAINMENT – LESSONS LEARNT ON AN AGEING AIRCRAFT

Paul van Staden*

***Boeing Defence Australia Limited**

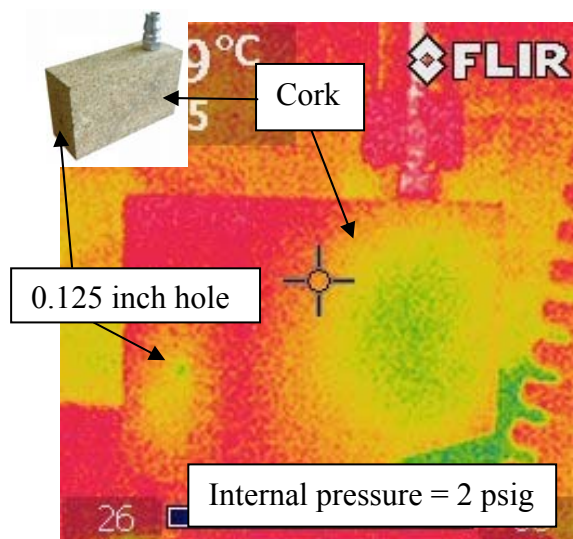
Figure 4.1 Thermal Conductivity

The perceived shortcomings of infrared leak detection have been further investigated with respect to thermal conductivity, minimum leak path size and low pressurization limits.

Through ‘amplification’ (without the use of hazardous substances) of the infrared signal, the performance of infrared leak detection has been significantly increased as shown in Figures 4.1, 4.2 and 4.3 below.
