STRUCTURAL TESTING OF C-5A AFT FUSELAGE SKIN PANELS

Abstract

This paper provides a description of how the structural integrity testing of C-5A aft fuselage crown skin panels was conducted.

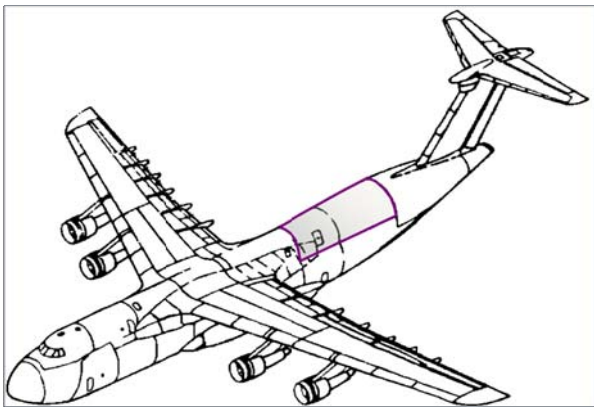
Fig. 1. C-5A fuselage aft crown region

From a fatigue standpoint, the C-5A design has proven successful. Based on results from the full scale fatigue test, as well as recent analytical studies at Lockheed Martin, the airframe is expected to remain free of widespread fatigue damage until well past its current planned retirement date. However, as has happened in a number of other aircraft designs, a type of structural degradation has occurred in 7079-T6 skin that could not have been foreseen 45 years ago. Cracks have been found during structural inspections of the aft upper fuselage (aft crown) region. This region is shown in Figure 1.

Lockheed Martin and the U.S. Air Force undertook fractographic and metallurgical analyses of the damaged skin and concluded that the cracks were not due to fatigue cycles, but were a type of stress corrosion cracking (SCC). This conclusion is further supported by the observation that, in many cases, the cracks have occurred in locations and orientations where the operational applied stress levels are known to be very low. The cracks in the low-stress regions may be thought of as nuisance cracks that can be managed by a “find and fix” approach through the normal maintenance programs. But, the random nature of the orientations and locations of these cracks also means that some will occur in high-stress regions and in the most critical orientation (perpendicular to the maximum principal applied tension stress). Adding to the analytical complexity is the fact that no reliable method

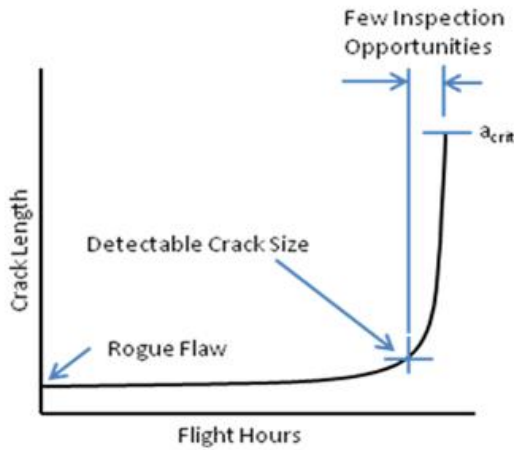
Fig. 3. Crack growth curves and inspection opportunities, stress corrosion crack growth

In the case of the aft crown, however, fleet evidence shows that some of the stress corrosion cracks in the aft crown make an abrupt transition to fast crack growth as shown in Figure 3.

Rapid growth such as this requires frequent inspections to catch cracks in the window of opportunity between detectable and critical crack lengths. The current crack growth analysis terminates at the first instant the crack tip stress intensity (at design limit load) exceeds the material toughness, K_c . That is, despite the fact that the aft crown is a stringer-stiffened construction, the legacy residual strength analysis has not credited the stringers with crack arrest capability. If it could be proven that the stringers do in fact maintain crack stability for longer lengths; then the inspectability of the structure would be greatly improved.

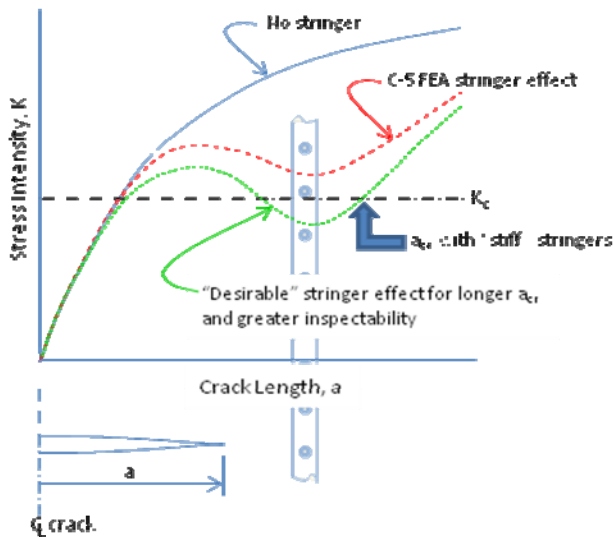
Fig. 5. Crack stability curve with stiffener effects

As shown in Figure 5, the FEA indicates the stringer does not provide enough stiffness (crack closing effect) to arrest a crack. Test evidence is needed that can prove the previous analytical estimates are conservative and critical crack length is significantly longer.

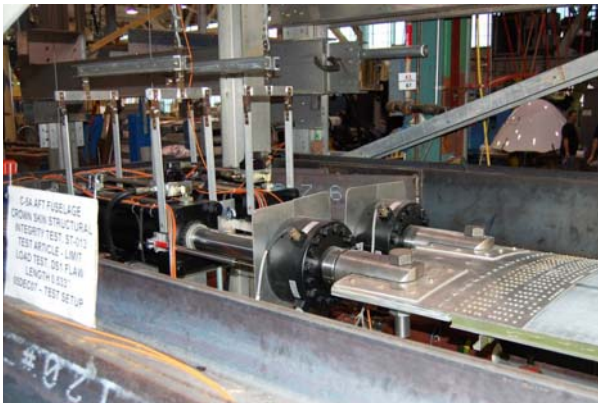
Fig. 10. ST-013 test article in test fixture

ST-013 was the first skin panel section tested and basically resulted in being a development tool for establishing the test procedures for the remaining test articles. The test article was mounted in the test fixture as shown in Figure 10.

A series of low level static tests were conducted to verify that the loading system would accurately and repeatedly produce the desired loads in the test area of the panel. The results of this testing were very positive and showed that the axial loads induced in the panel produced nearly constant and repeatable strains across the panel with very low levels of bending based on the strain gage data. As a result, the

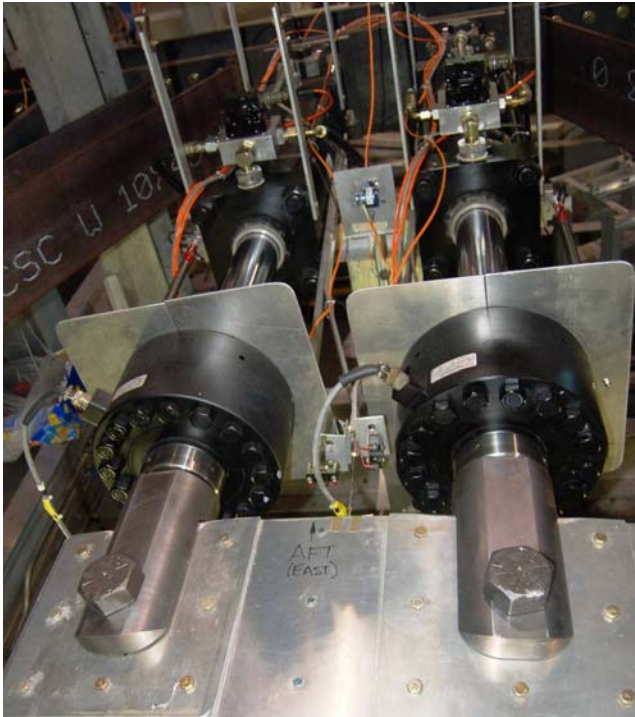
Fig. 12. ST-013 cyclic test setup

Cyclic testing was then started at this test load of 28,750 pounds (8 ksi). Figure 12 shows the cyclic test setup.

Inspection of the article was performed approximately every 12,000 cycles to monitor the crack growth from the ends of the induced flaw. No crack growth was detected from the flaw until the inspection at 60,000 cycles at which point a crack growth of 0.043 inches was noted on the inboard end of the flaw. Inspection intervals were then reduced to every 2,500 cycles. This crack continued to grow slowly with no growth from the other side of the flaw until 90,000 cycles had been completed at which point the inboard side measured 0.115 inches and a crack of 0.023 inches was detected on the outboard side. At 92,500 cycles an overall flaw length of 0.533 inches was reached and the first limit load test conducted.
