FATIGUE LIFE ANALYSIS OF MAIN LANDING GEAR PULL-ROD OF THE FIGHTER JET AIRCRAFT

Marcin Kurdelski, Andrzej Leski, Krzysztof Dragan
Air Force Institute of Technology, Warsaw, Poland

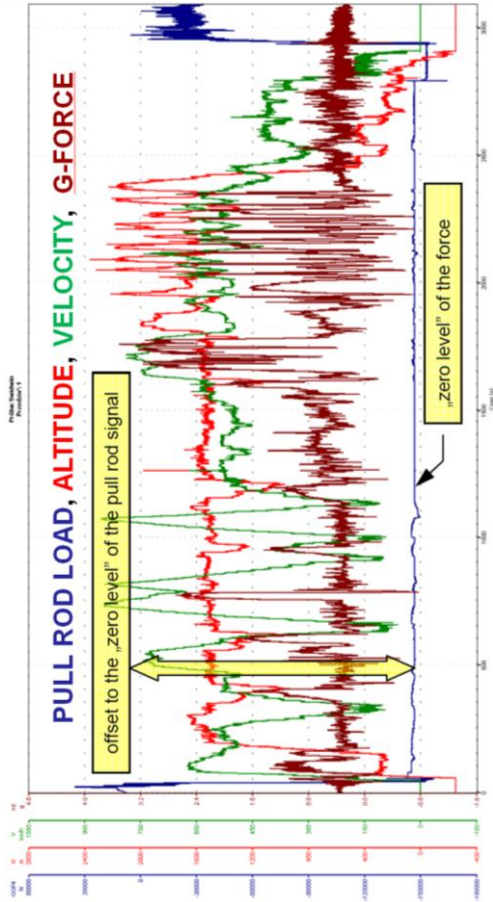
and engine tests. Flight tests have been prepared so that all the flight element blocks could be executed. One of the signals recorded was the force acting on the landing gear pull-rod, the subject of the present paper.

Fig. 7. Selected record of the test flight – H – altitude, V – velocity, nz – vertical acceleration, GGP4 – load in pull-rod signal

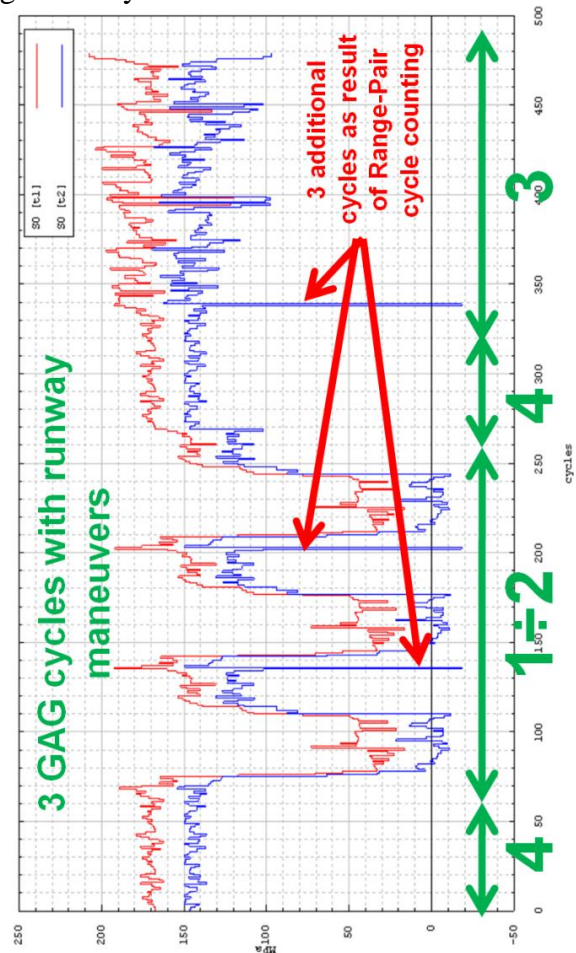
Fig. 11. Load sequence used in analysis

records of such flight elements, and because their realisation during tests poses a significant risk and a safety hazard. The load sequence to which the element has been submitted in the simulation is shown in Fig. 10. The load sequence has been adequately modified. The modifications consisted of filtering of the load sequence with the cycle truncation in the range above <20 MPa and of counting the cycles with the Range-Pair method. Load value truncation reduces the number of fatigue cycles which helps to reduce the calculation time, with minimal error in calculating critical crack length and growth time. Cycle count reveals 3 GAG cycles in the load sequence. Not performing the cycle count for the load sequence assumed significantly influences the end result.

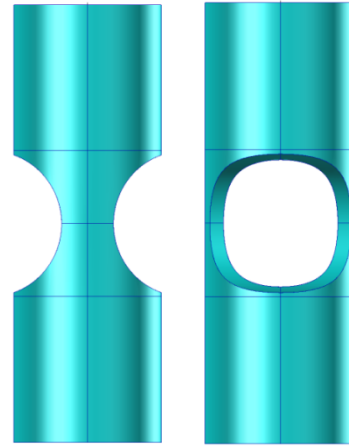
Fig. 13. Numerical model of the pull rod fatigue test specimen

The second specimen has been subjected to loads varying from 1 kN to 52 kN throughout the test. Every 1000 cycles, an overload cycle was introduced with 120% value of load (62,4 kN). The specimen (subjected to loads as described) withstood 192 500 cycles to failure. The observed cracks propagated from the inner edges of the specimens. The crack propagation was not uniform between the load paths.

The crack initiated at the inner edge, despite of the presence of an incision at the wall surface. Because of the geometry, the specimens were locally subjected not only to tension but also significant bending. The FE model has been subjected to the load of 52 kN which was equal to the load value used in the tests.

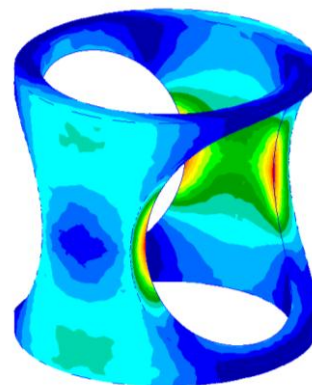
Fig. 14. Tension analysis (fatigue test load level) 52 kN Load, 760 MPa – HMH stress

Finite element calculations established that the Von Mises equivalent stress at the specimen edge reached 760 MPa. Actual loading of the cross section has been found to be more than two times larger than the analytical predictions for tension loading in the critical area.
