PRE-STRESSED MODAL ANALYSIS OF A TURBINE SPACER

M. Attia, J. Hou

**Air Vehicles Division, Defence Science & Technology Organisation (DSTO)
506 Lorimer St, Fishermans Bend, Victoria Australia**

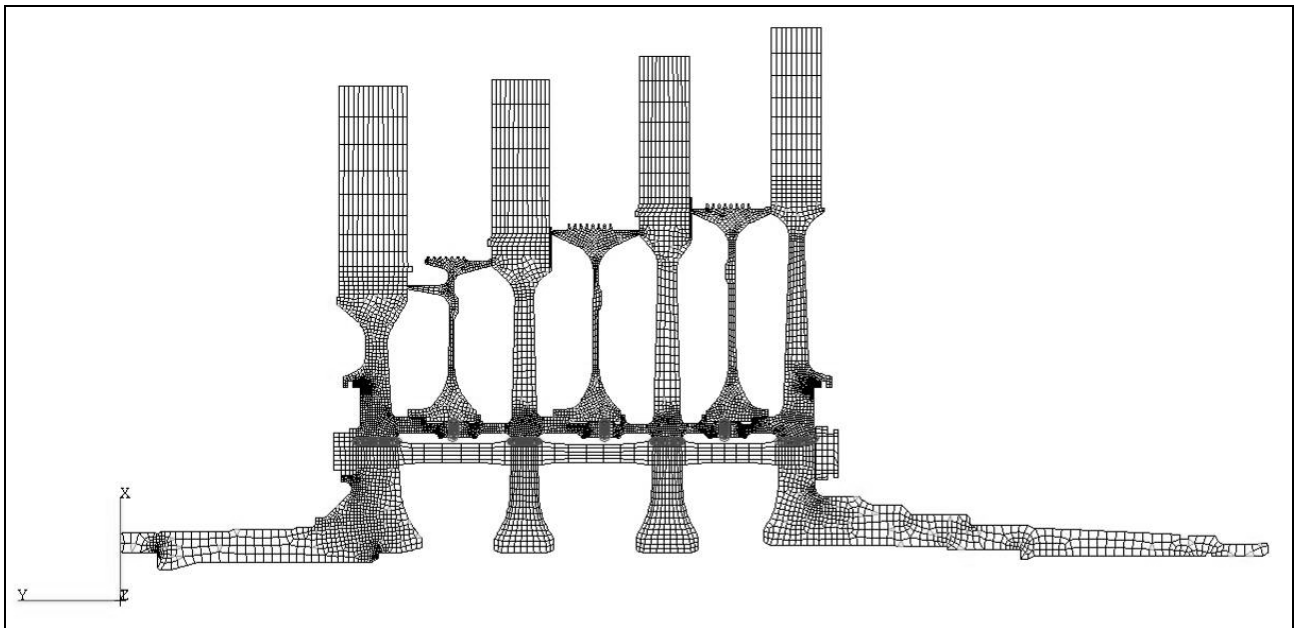
An initial 2D axi-symmetric FE model of the turbine assembly of the gas turbine engine was used to create a 3D sub-model of the spacer. The 2D model, as shown in Figure 1, including all of the turbine discs, blades and spacers, as well as the tie bolts, was validated under a different program. The model also included a loading history and FE results corresponding to a complete flight profile.

Fig. 1. 2D axis-symmetric FE model of the turbine assembly.

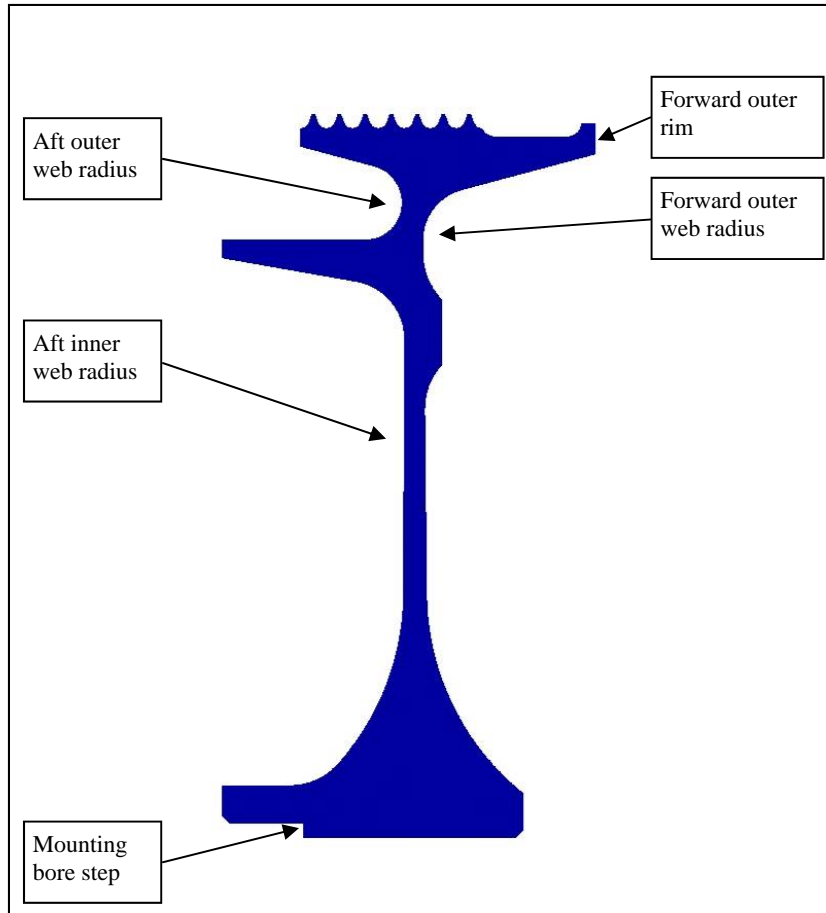
The Steady-state FE stress analysis was performed on the 3D model of spacer. This analysis simulated the static behaviour of the spacer under the take-off power condition. The schematic diagram of the spacer with labelling of the geometric features is shown in Figure 3.

Fig. 3. Schematic diagram with labelling of the special features of the spacer.
