A320 FULL SCALE STRUCTURAL TESTING FOR
FATIGUE AND DAMAGE TOLERANCE CERTIFICATION
OF METALLIC AND COMPOSITE STRUCTURE

B. Brandecker and R. Hilgert
Stress Department
Messerschmidt-Bölkow-Blohm GmbH
Hamburg, Federal Republic of Germany

Abstract

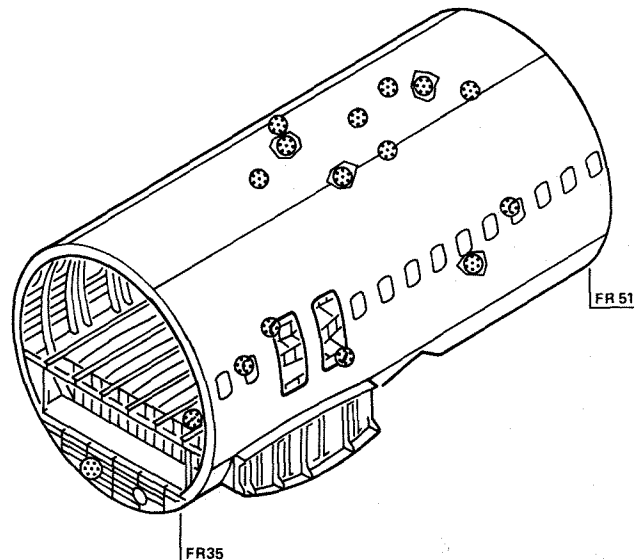
Figure 9: Artificial Damage Locations Center Fuselage

A summary of the artificial damages introduced in the A320 fuselage parts under MBB responsibility is shown in Figures 9 and 10. These areas represent structural significant items (SSI) which were included in the A320 certification analysis and for which inspections have been defined in the frame of the structural inspection program. The following major items are covered by damage tolerance testing (MBB design part):

- circumferential joints
- longitudinal joints
- cut-outs for doors, windows, antennas, fittings etc.
- pressure floor and keel beam
- attachment lugs for horizontal and vertical tailplanes
