# EMBRAER170 WING BIRD STRIKE TEST

**Akira Isoe, Toshimi Taki, and Tomio Okamoto**  
**Kawasaki Heavy Industries, Ltd.**

## Abstract

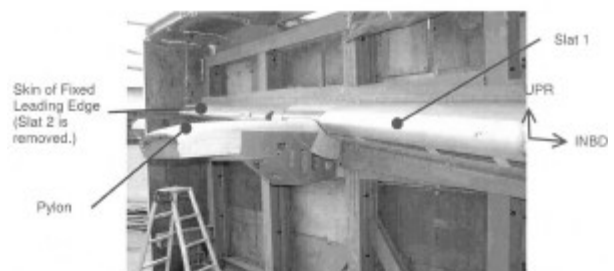
Fig.3 Test Model

The bird strike test article of the wing leading edge is shown in Fig. 3. The test article consists of two leading edge slats, wing fixed leading edge structure with a front spar and a pylon. Dummy wing skin and ribs of the wing box structure were provided to support the front spar. The test article is mostly made of aluminum alloy. Right-hand side of the structure was used as the test article.

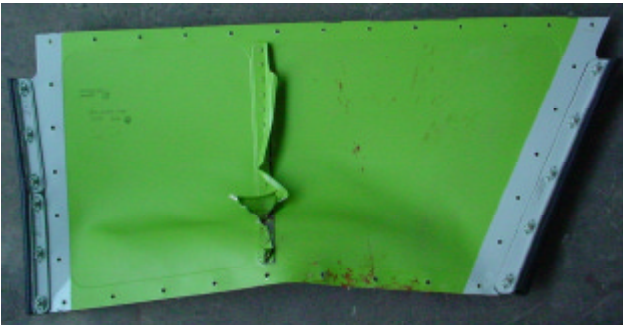
Fig.6 Results of the Test

Bird strike damage of the pylon cover area observed in the test is shown in figure 6. The skin of the pylon cover was deformed, but the skin was not torn. The cover reflected the bird upward and prevented the bird from entering the structure. A stiffener riveted inside of the cover skin was heavily deformed and cracked along the corner of the stiffener.

(a) Deformation of Pylon Cover

(b) Inside of Pylon Cover and Stiffener

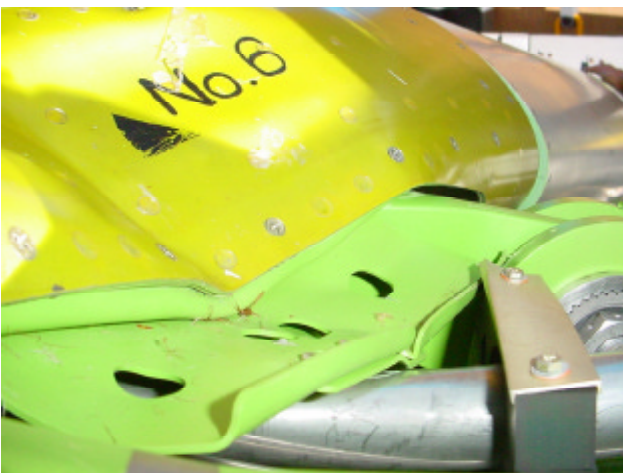
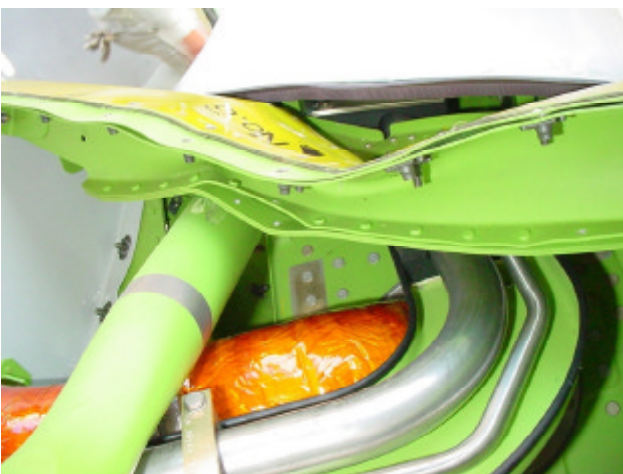
The H-section beam was also deformed, but the link rods supported the deformed beam as shown in figure 6 (d). The fuel line was hit by the deformed beam, but rupture of the fuel line did not occur. This test result proved that the improved design worked.

(c) H-Section Beam

(d) Fuel Pipe
