EFFECT OF STRESS ON MULTIPLE SITE DAMAGE

Abstract

Two kinds of panels with three rows of hole made of LY12-CZ aluminum alloy were tested under cyclic loads to study multiple site damage (MSD). It was found that panels were broken in three typical failure types; the probabilities of the first broken holes and failure happened at the middle row was almost the same as those happened at two lateral rows. The results also revealed that the stress level had a significant effect on the appearance of MSD: the larger maximum stress meant the easier occurrence of MSD; when the maximum stress was low to a certain extent, MSD would hardly happen.

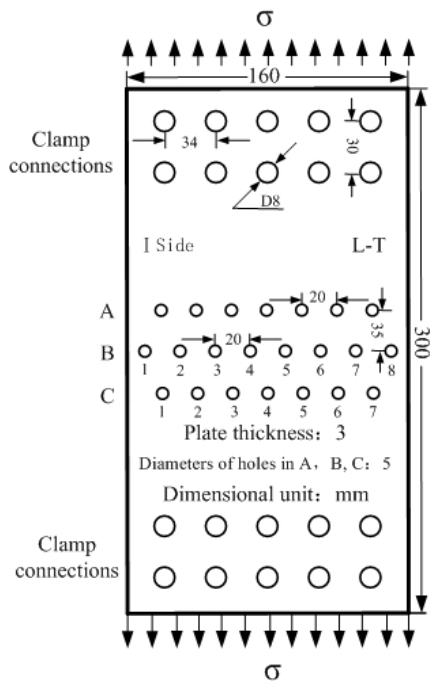
Two kinds of specimens were applied in tests: panels with three parallel rows of holes (a-type) and panels with three alternate rows of hole (b-type). The material of specimens was LY12-CZ and their thickness was 3mm. The front and back sides of panels were defined as Side I and Side II. Detailed geometrical sizes of specimens were shown in Fig. 1 and Fig. 2.

Fig. 2. Panel with Three Alternate Rows of Hole

gradually when cracks appeared in order to observe the growth and linkup of cracks. Fixtures were located at the end of specimens, and the material of fixtures was 45 steel. Bolts were used to joint clamps and specimens together and loads were also transferred to specimens by them. Dimensions of clamp connections were given in Fig. 1 and Fig. 2.

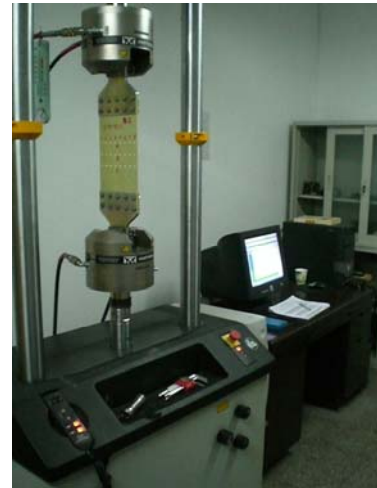
Instron8801 electro-hydraulic servo machine was used in tests, as shown in Fig. 3. Crack dimensions were measured with both vernier callipers and JVC reading microscope.

Fig. 3. Specimen Gripped in Fatigue Machine
