REPAIR CONCEPT SUPPORTED BY LASER REMOVAL AND INDUCTIVE HEATING

Markus Kaden*, Rüdiger Keck*

*German Aerospace Center

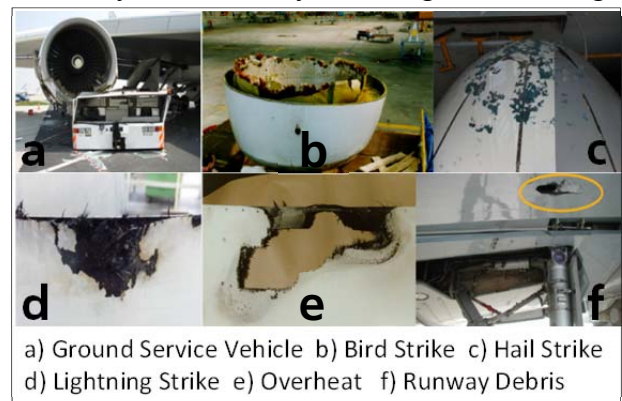
Figure 1 Aircraft damage scenarios [1]

In 2006, 1648 structural damages occurred on the 243 aircrafts in the Lufthansa fleet [1]. In 75 % of all cases, the damage was caused by mechanical effects, such as collision with ground servicing vehicles, jet bridges or runway debris. Lightning and bird strikes were mostly responsible for the remainder. In addition to these, hail strikes and overheating issues cause also damages. The different types of damage are pictured in FIGURE 1. A narrowbody aircraft suffers under structural damage statistically every 4600 flights, a widebody aircraft every 1000 flights on average.

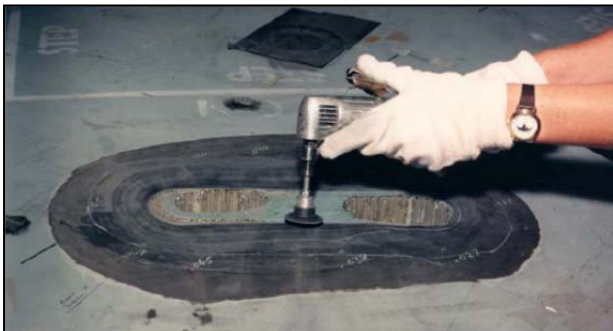
Figure 2 Manual removing of defected plies

The standardized steps of a common repair are described in the structural repair manual (SRM), which is issued and maintained by the OEMs. This manual contains the complete instructions to repair typical damages and is consulted, when the damage on a structural component is discovered. The repair process according to the SRM for hot bonded repairs starts with the localization of the damage. Its degree has to be assessed with the help of an applicable nondestructive testing method (NDT). Next step is to remove the defected material via eligible procedures. The structure of the repair depends on the damaged area and may have a complex 3-dimensional geometry. Regarding the geometrical requirements, the removals are scarfed manually. The difficulty by using a hand-held router is the imprecision of the tooling (FIGURE 2). In addition, well prepared chamfers or steps require a high level expertise of the servicing staff. There is a risk to create

more damage and contamination because of hand-held router handling. To avoid these problems, the use of a laser system is examined.

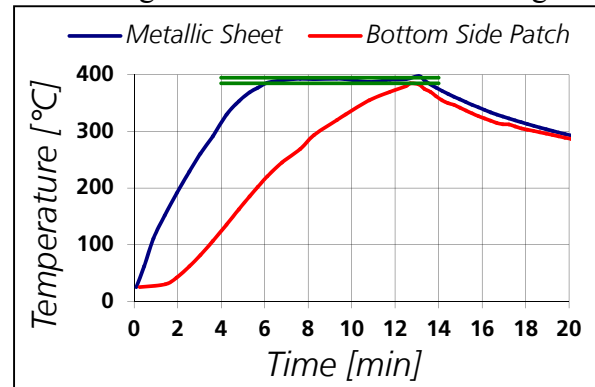
Figure 10 Heating Cycle of Patch Consolidation

combine with the parental laminate. Until the back side of the specimen plate reaches at least a temperature of approximately 390°C, the metallic sheet should be heated continuously. Once this temperature is reached, the heat generation should be turned off. A longer period of heat generation causes deformation and thermal damage on the structure around the repaired area. As can be seen in FIGURE 10, the heating of the metallic sheet is homogeneous

at both sides of the specimen plate. The green lines mark the field with a good processability temperature, for PEEK in the range between 385°C and 395°C. In further experiments, one of the aims is to reduce the process time, especially the soaking time to the back side of the laminate.
