William P. Schonberg
Department of Mechanical Engineering
University of Alabama in Huntsville
Huntsville, Alabama 35899

ABSTRACT

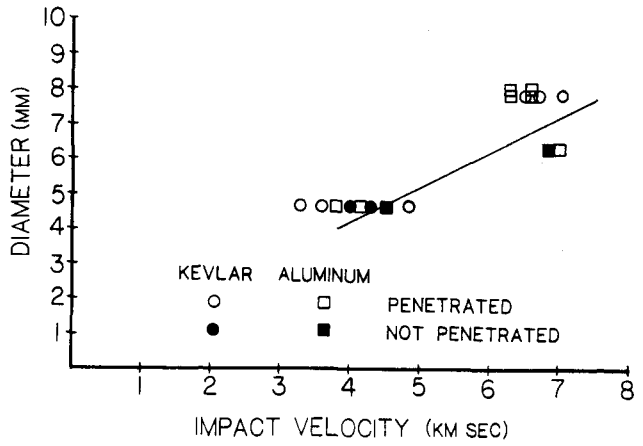
Fig. 2 Penetration Function for Kevlar ($t_s=3.8$ mm) and Alum. ($t_s=1.6$ mm) Dual-Wall Structures ($t_w=3.175$ mm, $S=101.6$ mm)

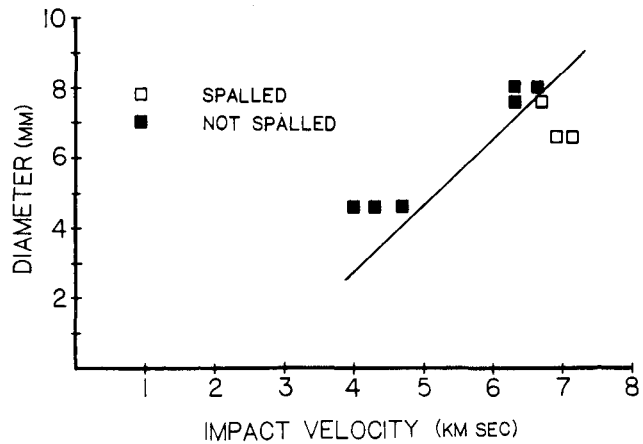
Fig. 3 Spall Function for Aluminum Dual-Wall Structures ($t_s=1.6$ mm, $t_w=3.175$ mm, $S=101.6$ mm)

It is interesting to note that the reverse sides of the pressure wall plates of the Kevlar systems did not exhibit any spall at either stand-off distance, while those of the aluminum systems exhibited significant spalling at both stand-off distances. A spall function for the aluminum systems considered in this investigation is presented in Figure 3. This increased tendency for spall in the aluminum specimens is a direct consequence of the wider areal distribution of the impulse delivered by the secondary debris fragment cloud. The impulse delivered to the pressure wall plate in the Kevlar systems is more concentrated and therefore serves to penetrate the plate rather than cause spall.

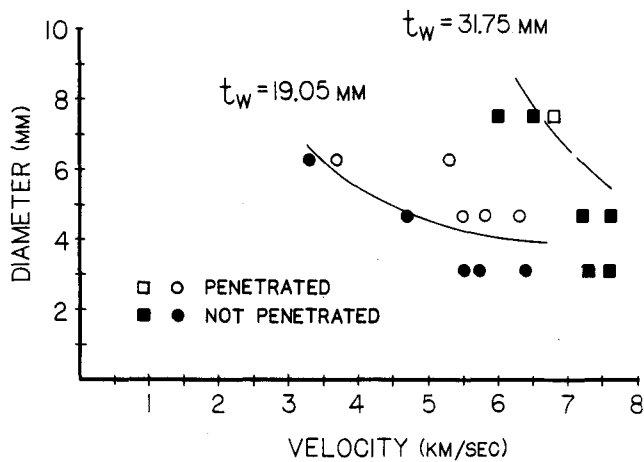
Fig. 6 Penetration Functions for Lexgard Windows

A summary of the damage to each of the Lexgard specimens can be found in Table 15 where D is the diameter of the hole in the specimen if penetration occurred, A_d is the area of the internal damage region, and A_s is the area of rear surface spall if spall occurred. Penetration functions for normal impact of both specimen types are shown in Figure 6 based on the penetration data in Table 15; a spall function for the normal impact of the thin Lexgard panels is shown in Figure 7. These curves can be used to determine if penetration or rear-surface spall will occur as a result of a particular high velocity impact. It is noted that the curves in Figures 6,7 are lines of demarcation between areas of penetration, no penetration and spall, no spall for the parameters indicated.

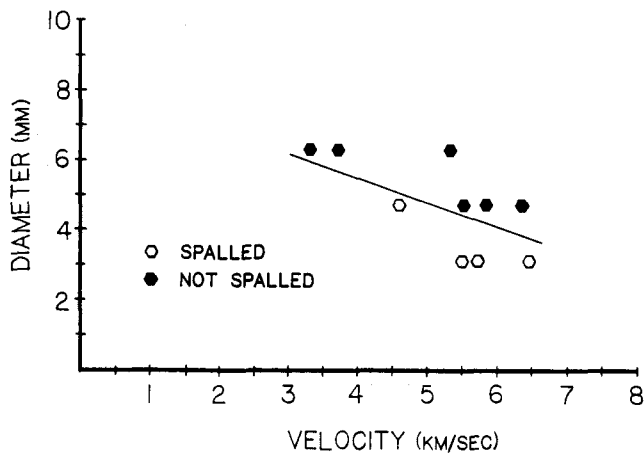
Fig. 7 Spall Function for Thin Lexgard Window
